## PROJECT CLEARANCE REPORT

Address of the Inspected Property: **341 Pennington Street, Moores Mills, BC**

**Pre-Remediation Assessment***August 5, 2022*

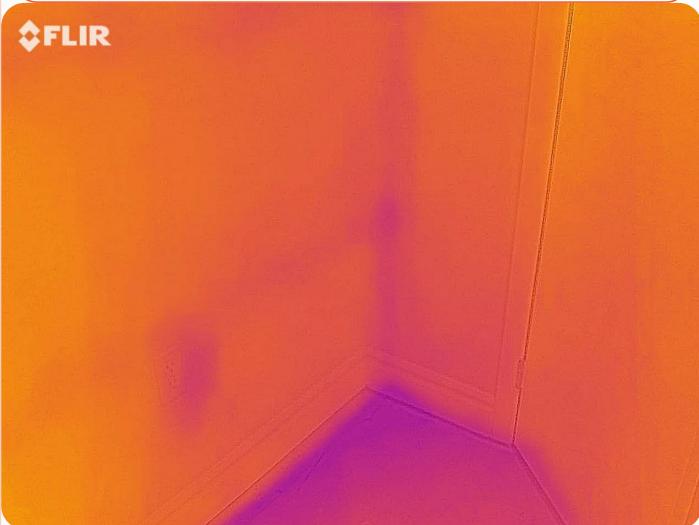
*During the remediation process, it was revealed that other areas of the basement were contaminated as well. Evidence of mice tunneling through the insulation explained the thermal anomalies observed. This degradation could impact the integrity of the insulants, exacerbating condensation issues behind the wall cavity which lead to a scope increase. The Project Supervisor suggested that all drywall, vapor barrier, and other affected organic-based materials be around the perimeter of the basement area. The client approved the scope increase and all suggestions were added to the existing plan of action.*

Pre-Remediation Assessment: August 5, 2022;  
thermal anomalies detected

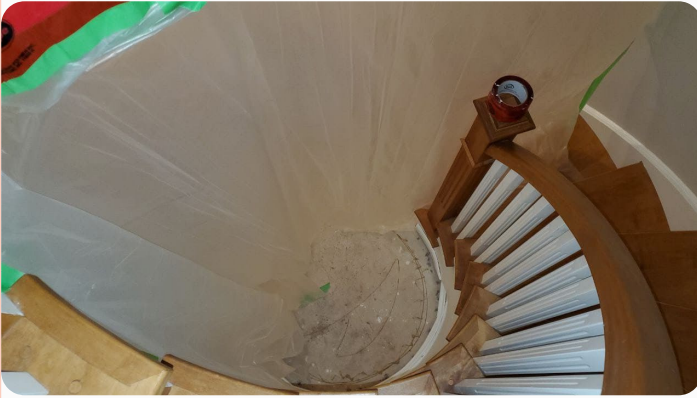
*Remediation Project: August 12, 2022;  
Containment setup*

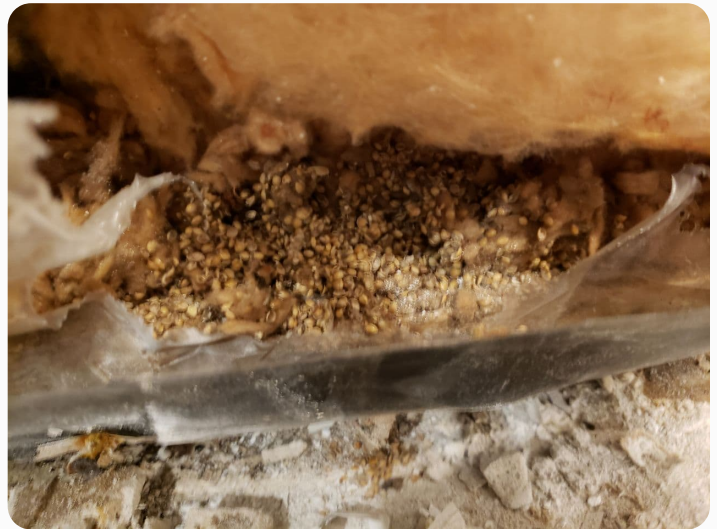
- The contaminated area was isolated in order to prevent cross-contamination to the unaffected areas of the property and to protect them from dust and debris during the remediation process;
- All compromised, contaminated, and moldy materials were removed from the affected areas and disposed of in 6 ml double bags. These materials included drywall, insulation, vapor barrier;
- Other affected organic-based materials were removed from the affected areas on an as-needed basis;
- During the remediation process mice infestation was noted in the basement area due to the affected insulation that was found to be disturbed;

*Remediation Project: August 12, 2022; An  
evidence of mice droppings was found*

1. It is recommended to contact a pest control specialist to assess, correct and implement preventative measures against further rodent activity;

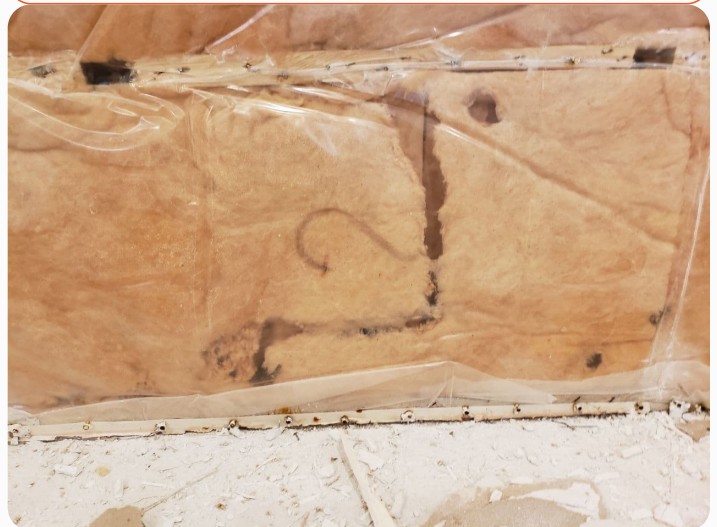
*Remediation Project: August 12, 2022; An  
evidence of mice tunneling found within the  
insulation*

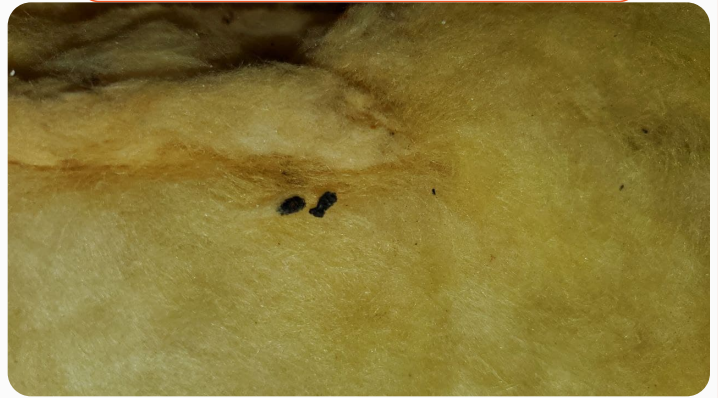
*Remediation Project: August 12, 2022; More evidence of mice infestation found*

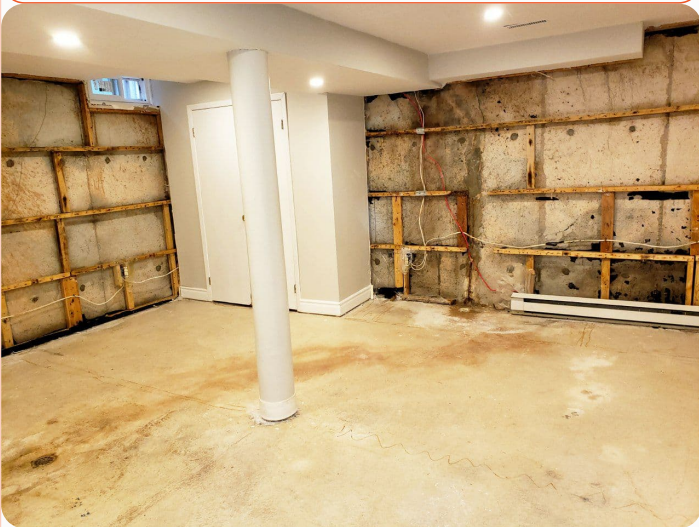
*Remediation Project: August 12, 2022; Completed work; Visual inspection*

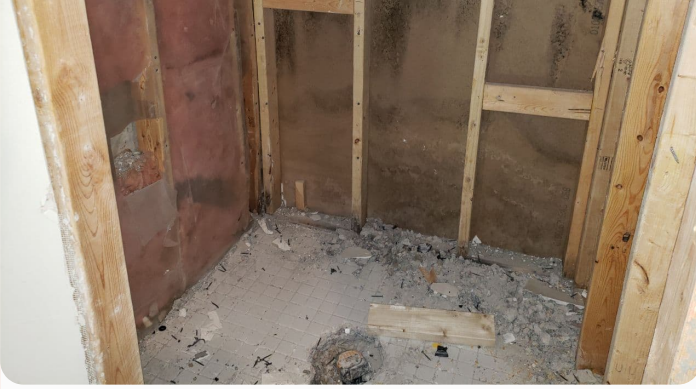
- At the time of the assessment the shower area was found to be in the renovation process, and visual mold was found behind the wall, however, the client mutually agreed not to continue with work as per personal reasons;

*Post-Remediation Verification: August 19, 2022;  
Shower area found to be in the renovation  
process at the time of the assessment*

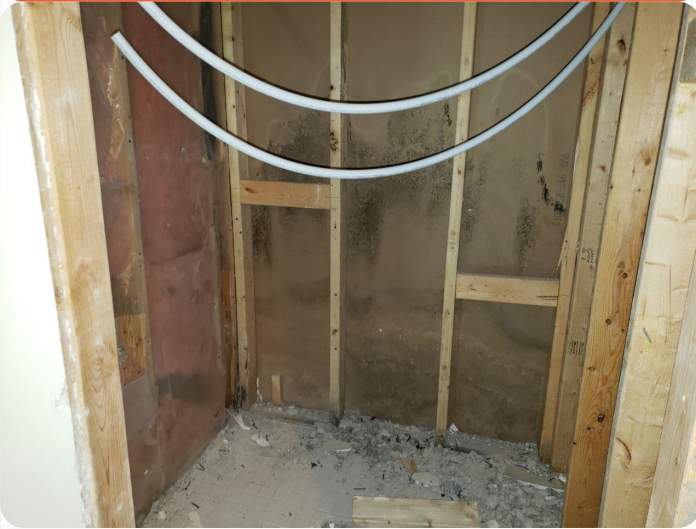
*Post-Remediation Verification: August 19,  
2022;; Visual mold observed on the wall behind  
removed shower*

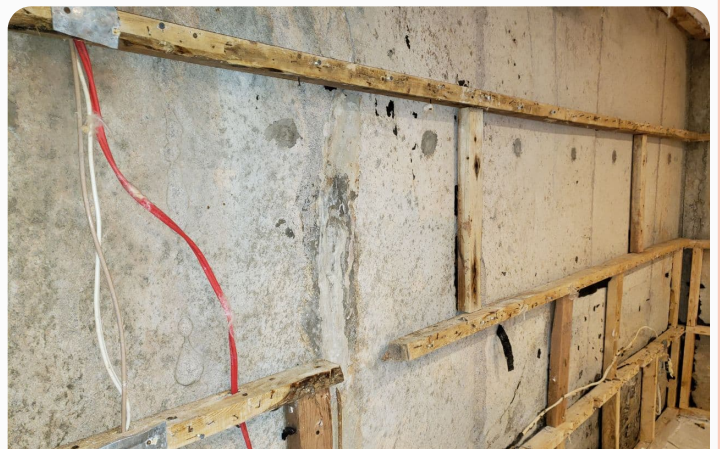
- Visual assessment of the treated area revealed cracks on several areas of the foundation walls;
- A discolored portion of the framing components was observed; An instant swab test was performed to determine the nature of the discoloration, and the results yielded a negative analysis for biological contaminant (i.e., fungi); The observed discoloration is non-fungal in nature;

Post-Remediation Verification: August 19, 2022;  
An evidence of crack in the foundation wall

2. It is recommended to contact a foundation specialist to check the integrity of the foundation walls and fix any issue;

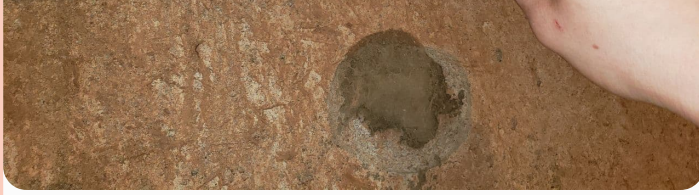
*Post-Remediation Verification: August 19, 2022;  
Swab test performed along the discolored  
portion of the framing component*

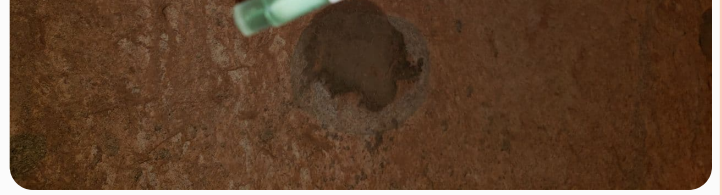
*Post-Remediation Verification: August 19, 2022;  
Negative results for biological contaminant (i.e.,  
fungi); discoloration non-fungal in nature*
