PROJECT CLEARANCE REPORT

Address of the Inspected Property: **341 Pennington Street, Moores Mills, BC**

Pre-Remediation Assessment*August 5, 2022*

Post-Remediation Verification

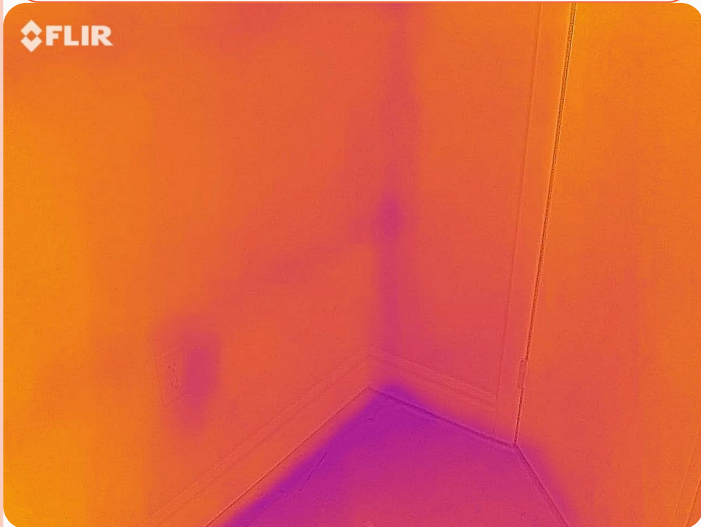
During the remediation process, it was revealed that other areas of the basement were contaminated as well. Evidence of mice tunneling through the insulation explained the thermal anomalies observed. This degradation could impact the integrity of the insulants, exacerbating condensation issues behind the wall cavity which lead to a scope increase. The Project Supervisor suggested that all drywall, vapor barrier, and other affected organic-based materials be around the perimeter of the basement area. The client approved the scope increase and all suggestions were added to the existing plan of action.

Pre-Remediation Assessment: August 5, 2022;
thermal anomalies detected

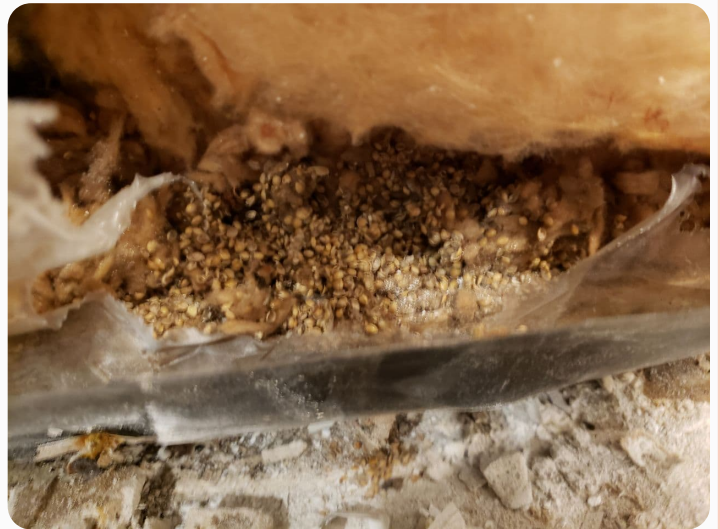
Remediation Project: August 12, 2022; An
evidence of mice droppings was found

1. It is recommended to contact a pest control specialist to assess, correct and implement preventative measures against further rodent activity;

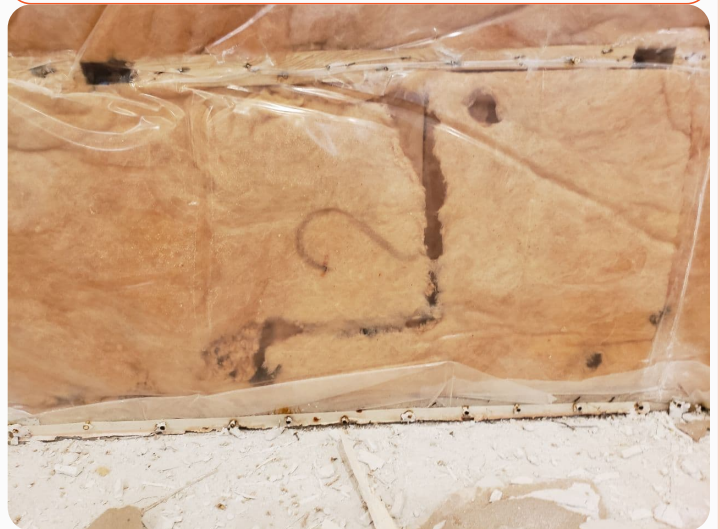
Remediation Project: August 12, 2022; An
evidence of mice tunneling found within the
insulation

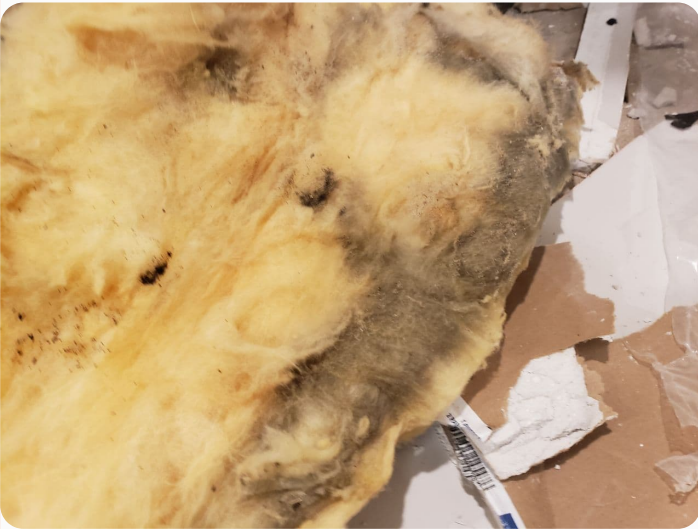
Remediation Project: August 12, 2022: Removal process

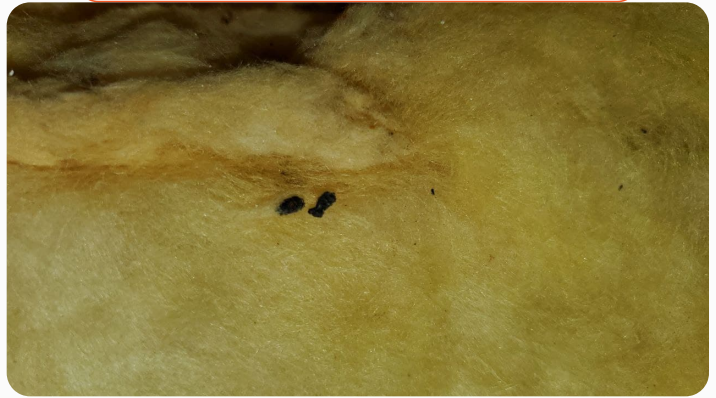
Remediation Project: August 12, 2022; More evidence of mice infestation found

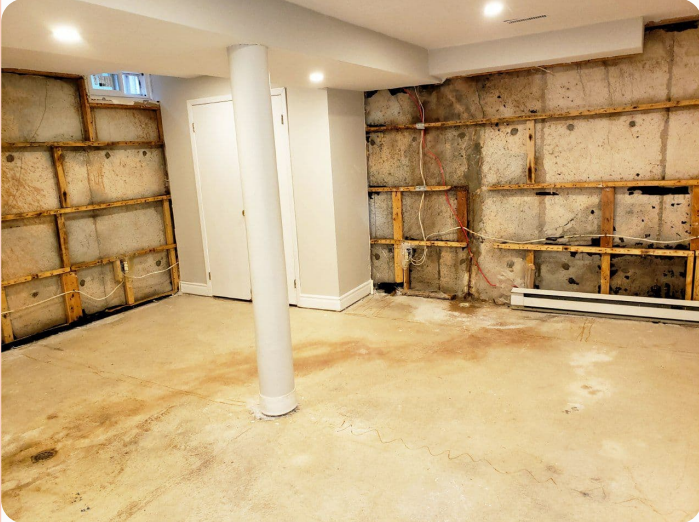
Remediation Project: August 12, 2022; Completed work; Visual inspection

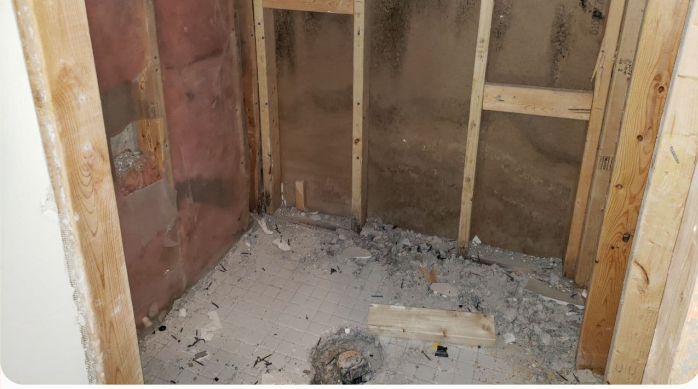
- At the time of the assessment the shower area was found to be in the renovation process, and visual mold was found behind the wall, however, the client mutually agreed not to continue with work as per personal reasons;

*Post-Remediation Verification: August 19, 2022;
Shower area found to be in the renovation
process at the time of the assessment*

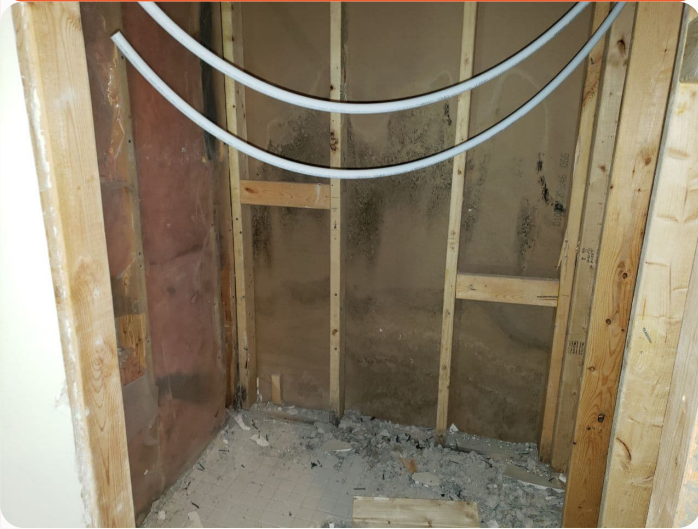
*Post-Remediation Verification: August 19,
2022;; Visual mold observed on the wall behind
removed shower*

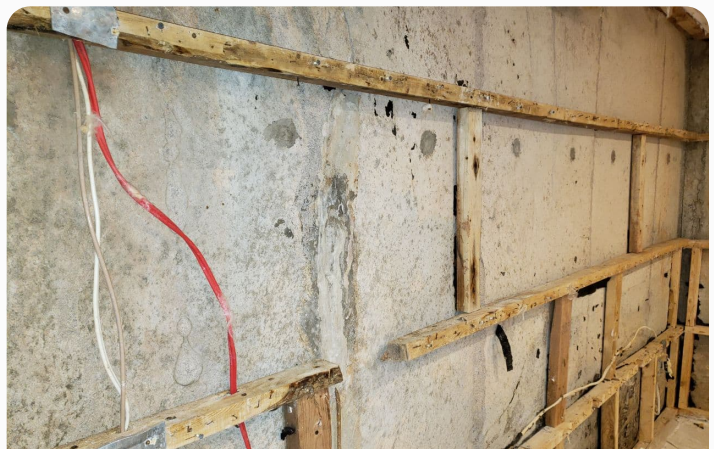
- Visual assessment of the treated area revealed cracks on several areas of the foundation walls;
- A discolored portion of the framing components was observed; An instant swab test was performed to determine the nature of the discoloration, and the results yielded a negative analysis for biological contaminant (i.e., fungi); The observed discoloration is non-fungal in nature;

Post-Remediation Verification: August 19, 2022;
An evidence of crack in the foundation wall

2. It is recommended to contact a foundation specialist to check the integrity of the foundation walls and fix any issue;

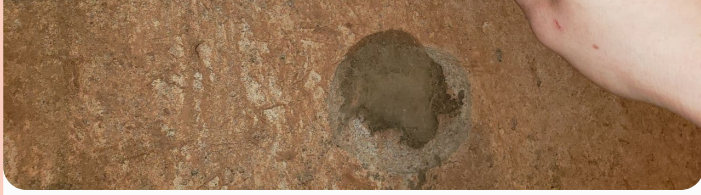
*Post-Remediation Verification: August 19, 2022;
Swab test performed along the discolored
portion of the framing component*
