PROJECT CLEARANCE REPORT

- **&** Report Prepared for: **Amelia Tremblay**
- Address of the Inspected Property: 341 Pennington Street, Moores Mills, BC

Date: August 12, 2022

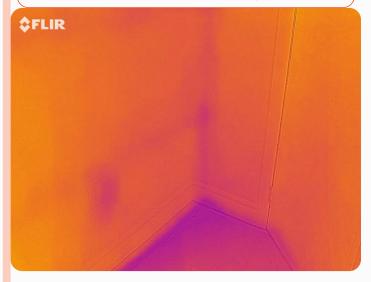
• The assessment confirmed the active moisture and discolored wood material at the base of the wall, additionally, thermal imaging revealed several thermal anomalies throughout the area;

Pre-Remediation Assessment: August 5, 2022; thermal anomalies detected

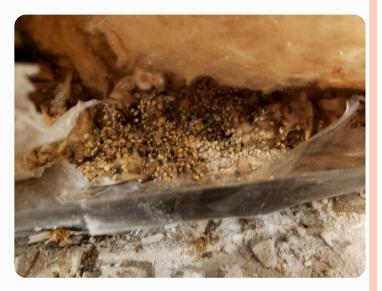
• During the remediation process mice infestation was noted in the basement area due to the affected insulation that was found to be disturbed;

Remediation Project: August 12, 2022; An evidence of mice droppings was found

1. It is recommended to contact a pest control specialist to assess, correct and implement preventative measures against further rodent activity;

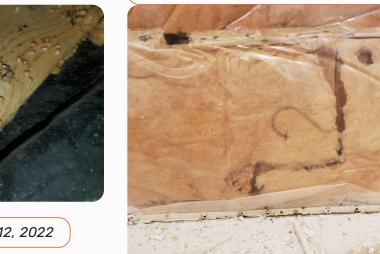
During the remediation process, it was revealed that other areas of the basement were contaminated as well. Evidence of mice tunneling through the insulation explained the thermal anomalies observed. This degradation could impact the integrity of the insulants, exacerbating condensation issues behind the wall cavity which lead to a scope increase. The Project Supervisor suggested that all drywall, vapor barrier, and other affected organic-based materials be around the perimeter of the basement area. The client approved the scope increase and all suggestions were added to the existing plan of action.

Remediation Project: August 12, 2022; An evidence of mice tunneling found within the insulation

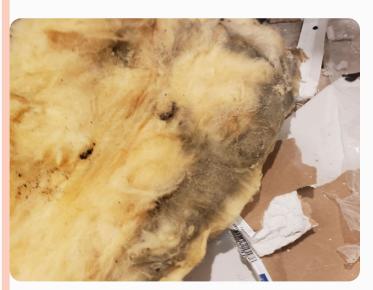
Remediation Project: August 12, 2022: Removal process

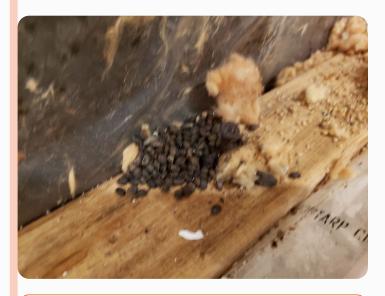
Remediation Project: August 12, 2022; More evidence of mice infestation found

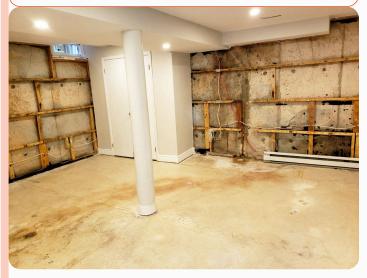
Remediation Project: August 12, 2022; Completed work; Visual inspection

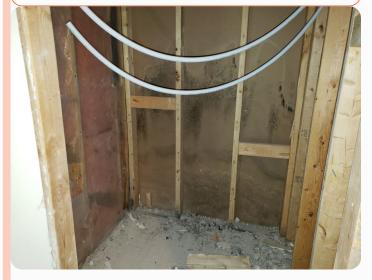
• At the time of the assessment the shower area was found to be in the renovation process, and visual mold was found behind the wall, however, the client mutually agreed not to continue with work as per personal reasons;

Post-Remediation Verification: August 19, 2022;; Visual mold observed on the wall behind removed shower

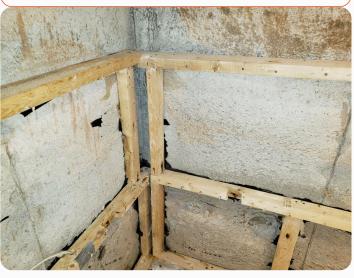
• Visual assessment of the treated area revealed cracks on several areas of the foundation walls;

Post-Remediation Verification: August 19, 2022; An evidence of crack in the foundation wall

2. It is recommended to contact a foundation specialist to check the integrity of the foundation walls and fix any issue;
