PROJECT CLEARANCE REPORT

Address of the Inspected Property: **341 Pennington Street, Moores Mills, BC**

Date: August 12, 2022

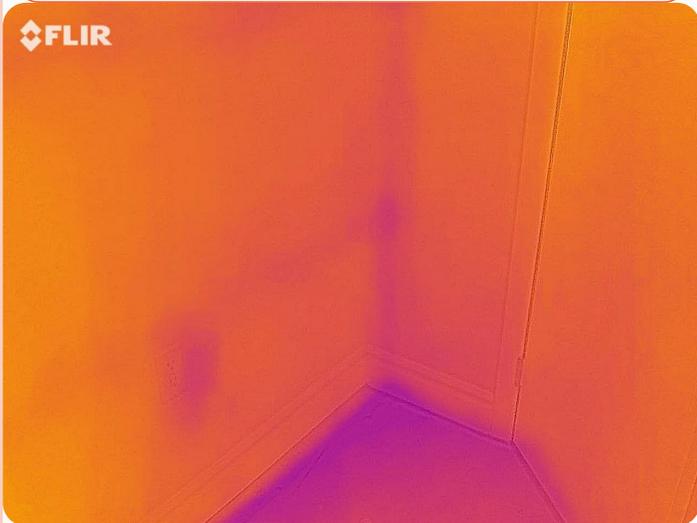
During the remediation process, it was revealed that other areas of the basement were contaminated as well. Evidence of mice tunneling through the insulation explained the thermal anomalies observed. This degradation could impact the integrity of the insulants, exacerbating condensation issues behind the wall cavity which lead to a scope increase. The Project Supervisor suggested that all drywall, vapor barrier, and other affected organic-based materials be around the perimeter of the basement area. The client approved the scope increase and all suggestions were added to the existing plan of action.

Pre-Remediation Assessment: August 5, 2022;
thermal anomalies detected

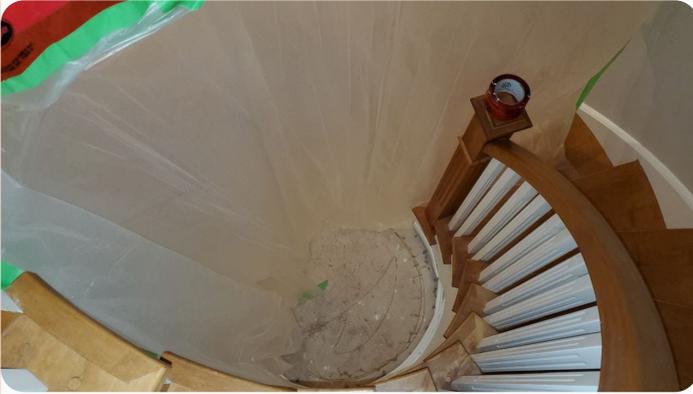
Remediation Project: August 12, 2022;
Containment setup

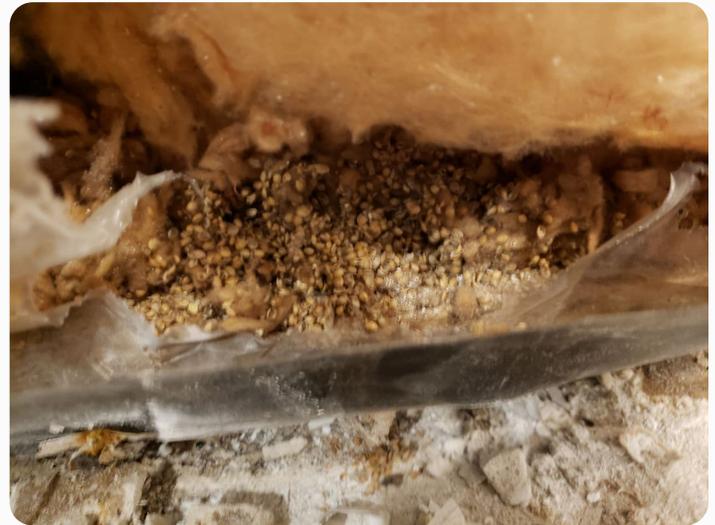
Remediation Project: August 12, 2022; An
evidence of mice droppings was found

1. It is recommended to contact a pest control specialist to assess, correct and implement preventative measures against further rodent activity;

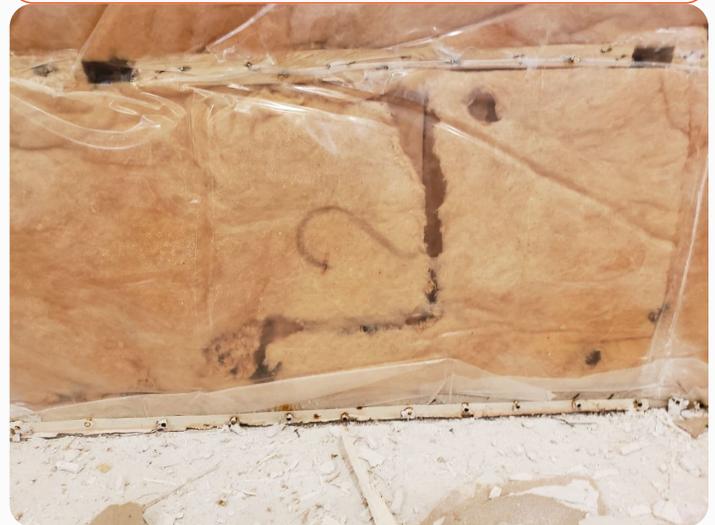
Remediation Project: August 12, 2022; An
evidence of mice tunneling found within the
insulation

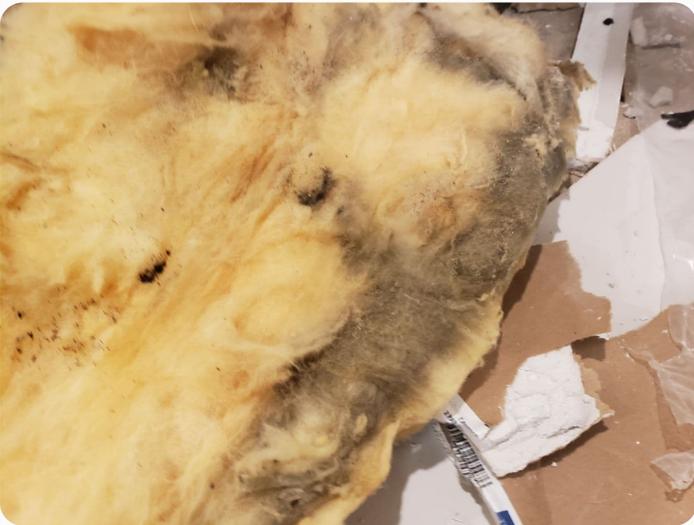
Remediation Project: August 12, 2022: Removal process

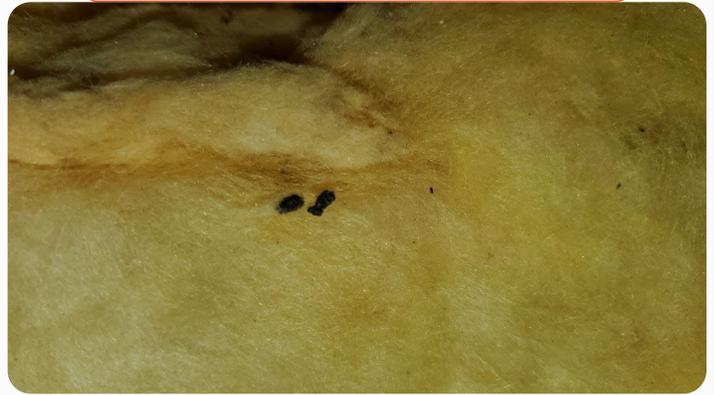
Remediation Project: August 12, 2022; More evidence of mice infestation found

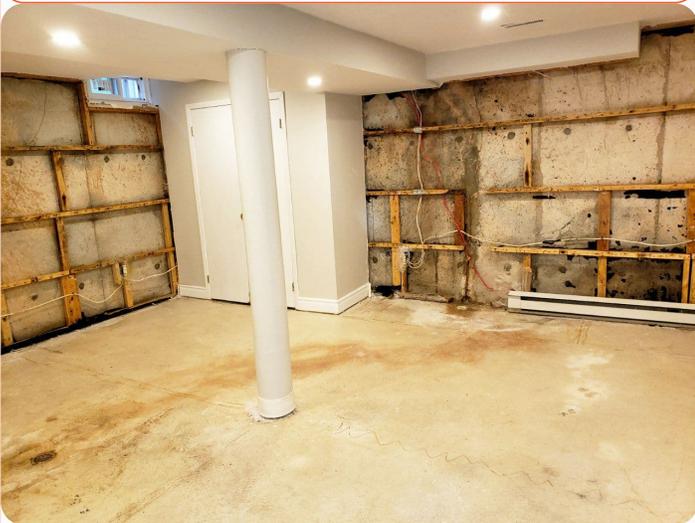
Remediation Project: August 12, 2022; Completed work; Visual inspection

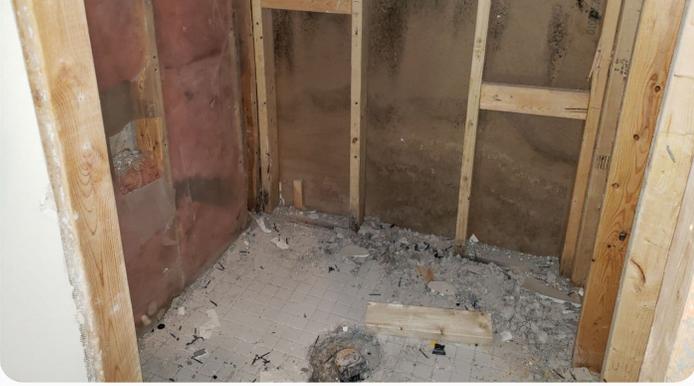
- At the time of the assessment the shower area was found to be in the renovation process, and visual mold was found behind the wall, however, the client mutually agreed not to continue with work as per personal reasons;

*Post-Remediation Verification: August 19, 2022;
Shower area found to be in the renovation
process at the time of the assessment*

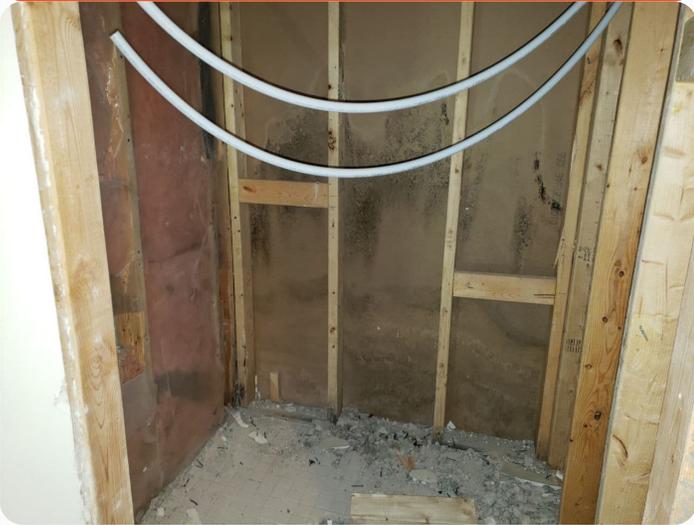
*Post-Remediation Verification: August 19,
2022;; Visual mold observed on the wall behind
removed shower*

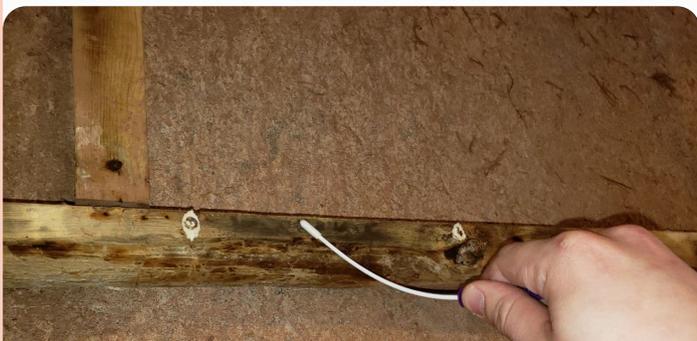
- Visual assessment of the treated area revealed cracks on several areas of the foundation walls;
- A discolored portion of the framing components was observed; An instant swab test was performed to determine the nature of the discoloration, and the results yielded a negative analysis for biological contaminant (i.e., fungi); The observed discoloration is non-fungal in nature;

Post-Remediation Verification: August 19, 2022;
An evidence of crack in the foundation wall

2. It is recommended to contact a foundation specialist to check the integrity of the foundation walls and fix any issue;

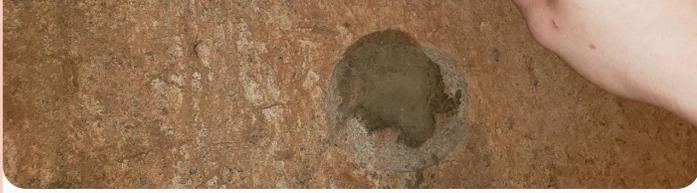
*Post-Remediation Verification: August 19, 2022;
Swab test performed along the discolored
portion of the framing component*

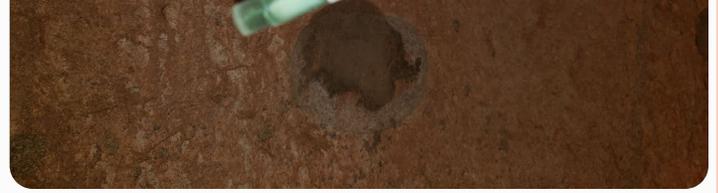
*Post-Remediation Verification: August 19, 2022;
Negative results for biological contaminant (i.e.,
fungi); discoloration non-fungal in nature*
