# INDOOR ENVIRONMENTAL ASSESSMENT

Address of the Inspected Property: **341 Pennington Street, Moores Mills, BC**

Date: August 18, 2022

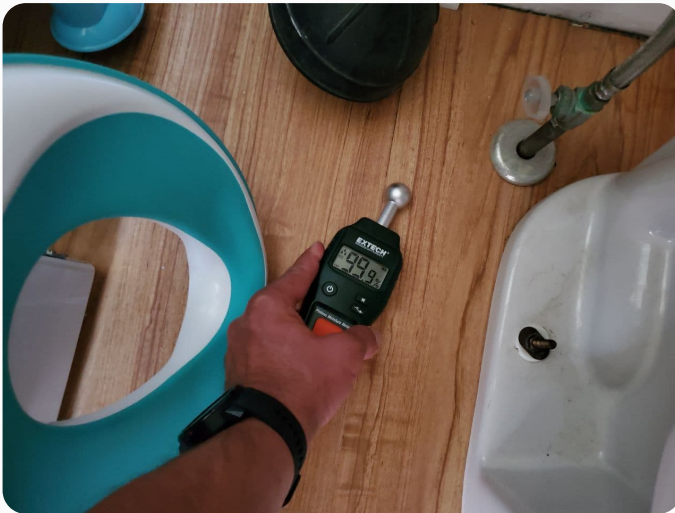
- At the time of the inspection, active moisture was detected along the flooring in the bathroom, near the toilet. This may be the result of a leaky seal, or compromised wax gasket.
- It is recommended to contact a plumber to assess and address any potential leak sources.
- Once the leak has been addressed, it is recommended to remove and/or treat the affected subflooring materials in the bathroom area.

*Active moisture detected around the toilet;  
main level*

- Professional mold remediation is recommended to be performed in the affected areas (basement area, main level bathroom and upper-level area) in accordance with Residential Mold Removal Guidelines.

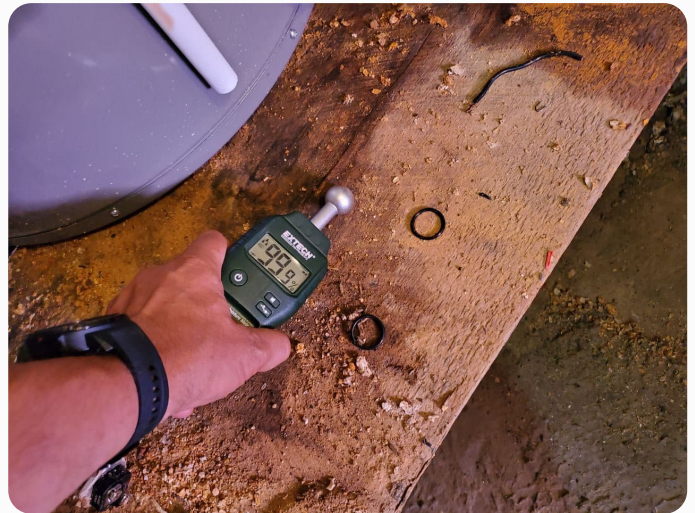
- Visible mold growth was observed on the walls and floors around the water tank and along the exterior walls in the Basement Area.
- Wood materials (plywood platform, framing, etc.) were found to be compromised by moisture, near the water tank area.

- A water valve near water tank area was found to be dripping at the time of the inspection, contributing to the moisture content along the floor.
- The floor in the basement area is exposed earth/stone; with no impermeable membrane. Water vapor emanating from the floor is contributing to the pervasive 'musty' odor observed at the time of the inspection.

*Wooden components affected by moisture  
around the water tank*

- This includes the removal of any non-structural building material that is contaminated with mold, active moisture, or rot. All residual surface areas will be thoroughly disinfected using HEPA vacuums and anti-fungal treatments.

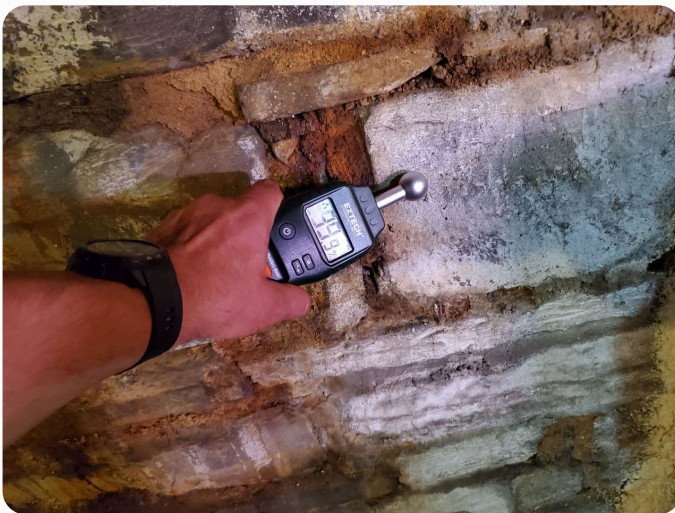
- The foundation walls were found to display evidence of moisture intrusions, by means of water staining and efflorescence. The age of the home and the materials used for the foundation wall materials may require a professional foundation specialist to assess the current state of the foundation wall materials.

- A moisture source contributing to the visible moisture issues in the basement along the foundation walls and flooring is related to inadequate moisture diversion strategies implemented along the exterior of the home.

*Active moisture content detected along the  
foundation walls in the Basement Area*

- It is recommended to have the foundation assessed and/or addressed by a professional in that field.
- It is recommended to improve the overall moisture diversion strategies along the exterior which includes extending downspouts away from the property, correcting the grading, ensuring eavestroughs are fully functional and to consider the installation of ice guards along the metal roof.

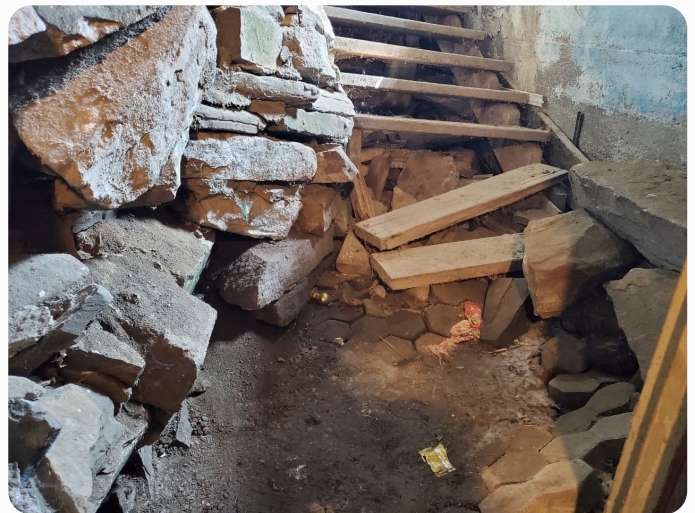
*Compromise to the stairs noted; entrance to  
the basement area*

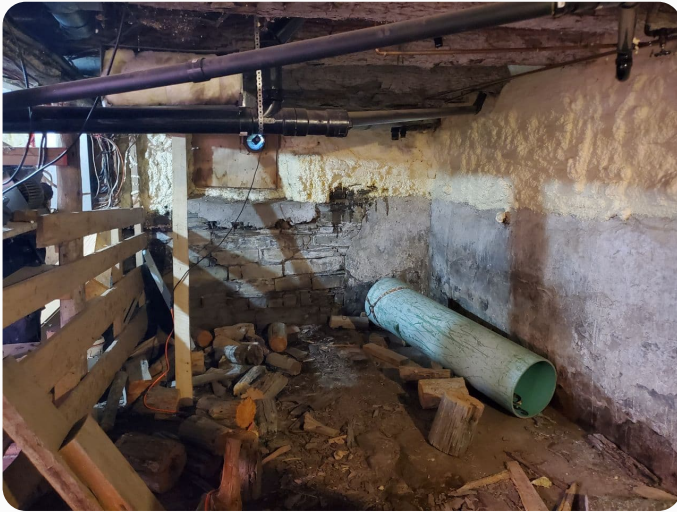
- It was observed that firewood and logs are being kept and possibly cut in the basement area. It is generally recommended to do so outside of the property so as to prevent the introduction of mold spores, termites or other sources of building contaminants that may be present in firewood, logs or other related materials.

*Accumulation of firewood & debris noted throughout the basement area; visible mold noted on the walls*

- It is recommended to avoid bringing in and chopping firewood in the interior of the home.

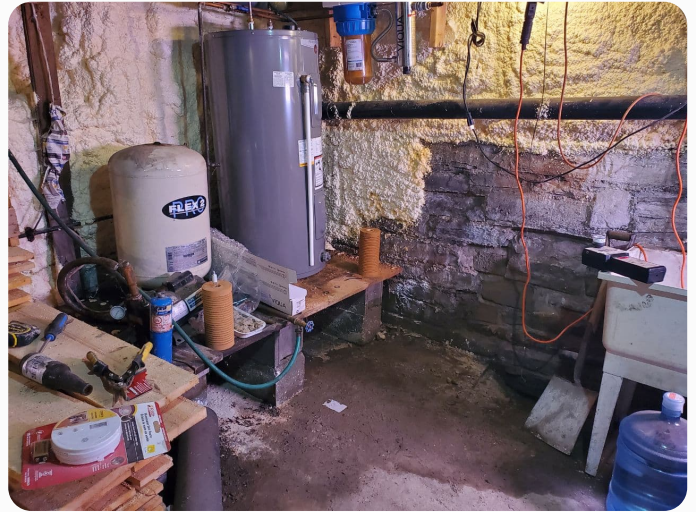
- It was observed that the basement area is partially insulated with polyurethane sprayfoam along the upper portions of the exterior walls. The lower portions are not insulated. This may create a thermal imbalance during the colder months, which can facilitate condensation and thus, conditions conducive to fungal growth.

*General photo of the water tank; partial insulation of exterior walls*

- It is recommended to ensure there is a polyethyelene membrane installed along the basement floor.
- It is recommended to insulate the remaining portion of the exterior walls in the basement area in order to achieve a more balanced thermal resistance.

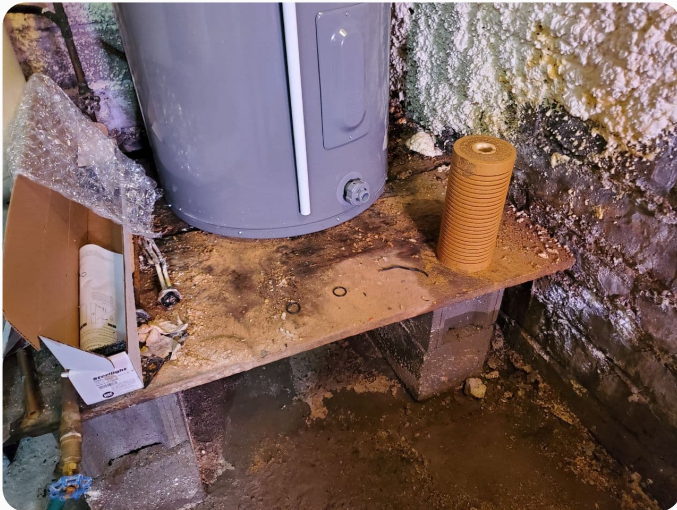
*Visible discoloration noted along the wood material*

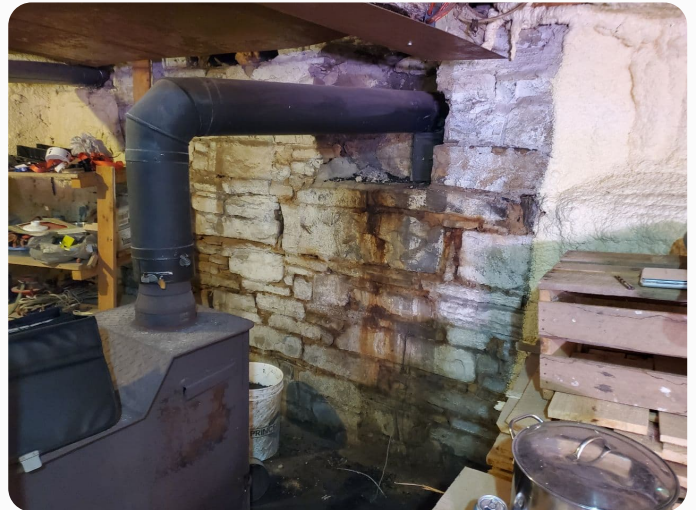
*Visible mold growth observed on the foundation walls*

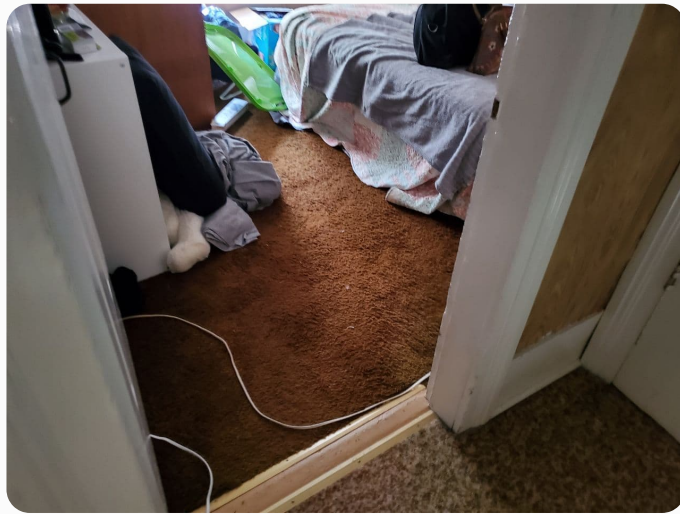
- At the time of the inspection, active moisture was detected along carpet found in the bedroom area.
- Evidence suggests that the source of the moisture found on the carpet may be from the window area.
- Moisture readings along the wall under the window area in the bedroom of concern did not yield any active moisture levels.
- Carpet is a highly retentive material that can trap particulates & allergens (pollen, spores, dust, etc.) and may increase reactions in individuals with predisposed sensitivities or medical conditions.
- It is recommended to remove the carpet in the affected bedroom area in order to better ascertain and address the moisture source; while removing the carpet as a potential source for contaminants.
- It is recommended to replace all carpets, especially if older than 10 years, with a non-porous alternative, such as laminate or hardwood.

*Upper level bedroom area; active moisture  
detected along the carpet*
