INDOOR ENVIRONMENTAL ASSESSMENT

Address of the Inspected Property: **341 Pennington Street, Moores Mills, BC**

Date: August 18, 2022

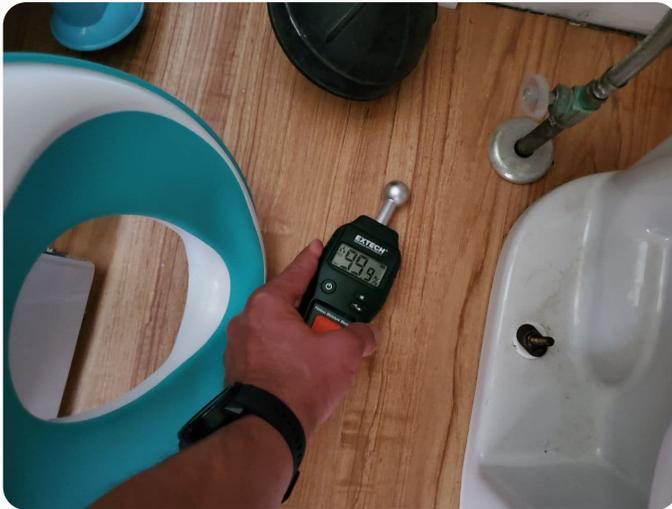
- At the time of the inspection, active moisture was detected along the flooring in the bathroom, near the toilet. This may be the result of a leaky seal, or compromised wax gasket.
- It is recommended to contact a plumber to assess and address any potential leak sources.
- Once the leak has been addressed, it is recommended to remove and/or treat the affected subflooring materials in the bathroom area.

*Active moisture detected around the toilet;
main level*

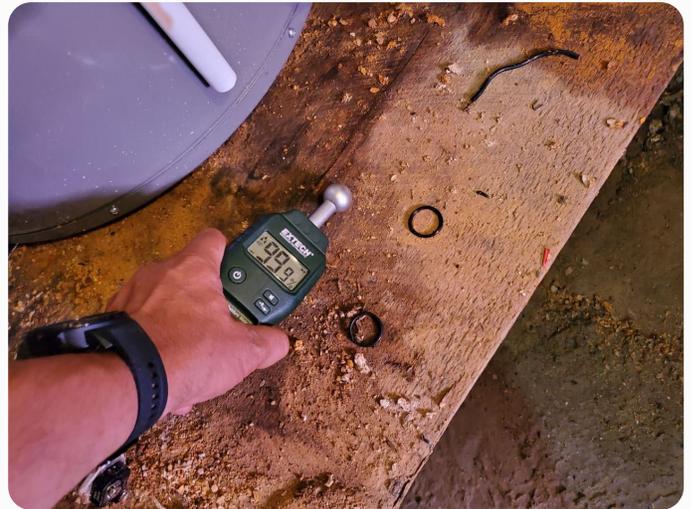
- Visible mold growth was observed on the walls and floors around the water tank and along the exterior walls in the Basement Area.
- Wood materials (plywood platform, framing, etc.) were found to be compromised by moisture, near the water tank area.

*Wooden components affected by moisture
around the water tank*

- This includes the removal of any non-structural building material that is contaminated with mold, active moisture, or rot. All residual surface areas will be thoroughly disinfected using HEPA vacuums and anti-fungal treatments.

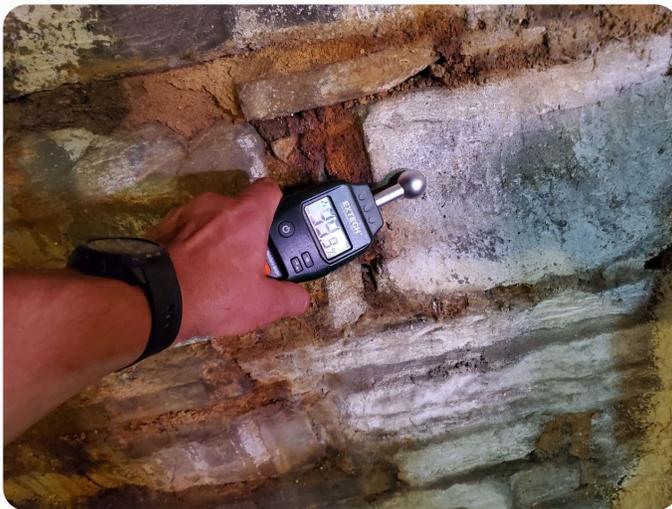
- The foundation walls were found to display evidence of moisture intrusions, by means of water staining and efflorescence. The age of the home and the materials used for the foundation wall materials may require a professional foundation specialist to assess the current state of the foundation wall materials.

- A moisture source contributing to the visible moisture issues in the basement along the foundation walls and flooring is related to inadequate moisture diversion strategies implemented along the exterior of the home.

*Active moisture content detected along the
foundation walls in the Basement Area*

- It is recommended to have the foundation assessed and/or addressed by a professional in that field.
- It is recommended to improve the overall moisture diversion strategies along the exterior which includes extending downspouts away from the property, correcting the grading, ensuring eavestroughs are fully functional and to consider the installation of ice guards along the metal roof.

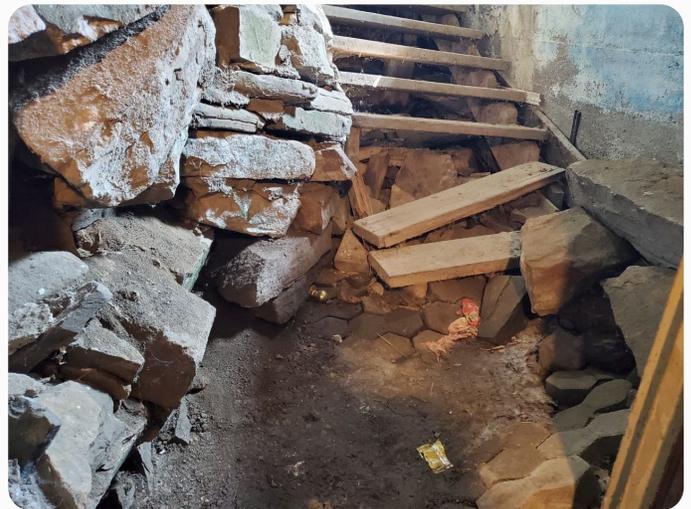
*Compromise to the stairs noted; entrance to
the basement area*

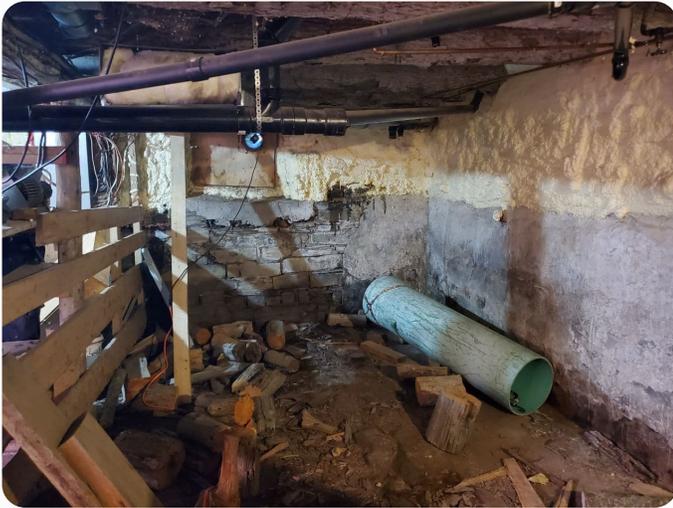
- It was observed that firewood and logs are being kept and possibly cut in the basement area. It is generally recommended to do so outside of the property so as to prevent the introduction of mold spores, termites or other sources of building contaminants that may be present in firewood, logs or other related materials.

Accumulation of firewood & debris noted throughout the basement area; visible mold noted on the walls

- It is recommended to avoid bringing in and chopping firewood in the interior of the home.

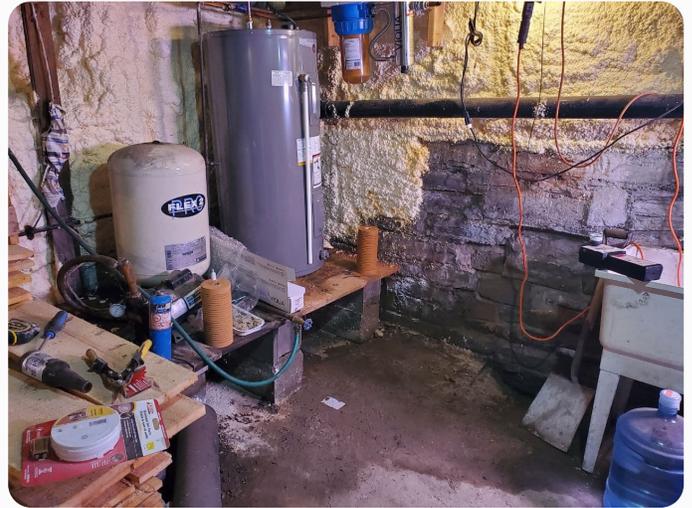
- It was observed that the basement area is partially insulated with polyurethane sprayfoam along the upper portions of the exterior walls. The lower portions are not insulated. This may create a thermal imbalance during the colder months, which can facilitate condensation and thus, conditions conducive to fungal growth.

General photo of the water tank; partial insulation of exterior walls

- It is recommended to ensure there is a polyethylene membrane installed along the basement floor.
- It is recommended to insulate the remaining portion of the exterior walls in the basement area in order to achieve a more balanced thermal resistance.

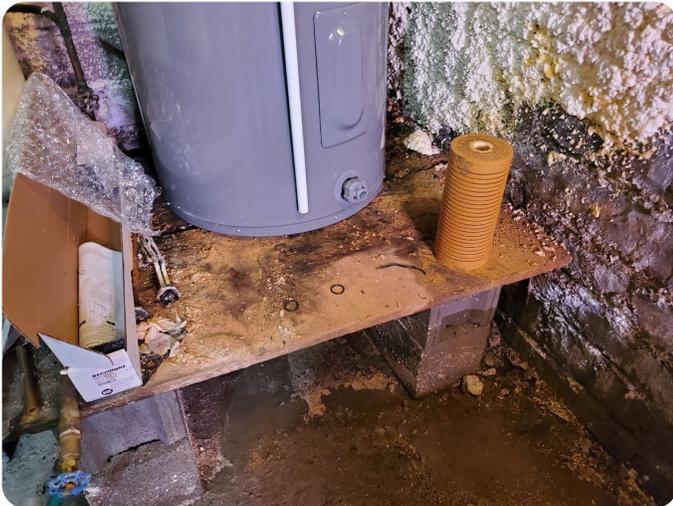
Visible discoloration noted along the wood material

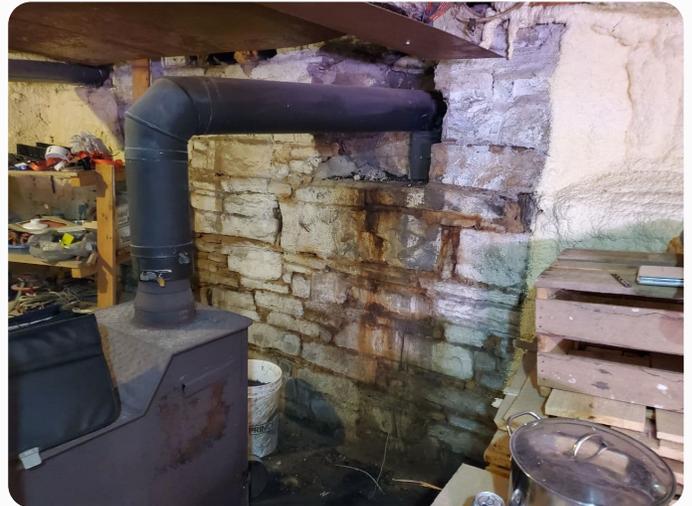
Visible mold growth observed on the foundation walls

- Professional mold remediation is recommended to be performed in the affected areas (basement area, main level bathroom and upper-level area) in accordance with Residential Mold Removal Guidelines.

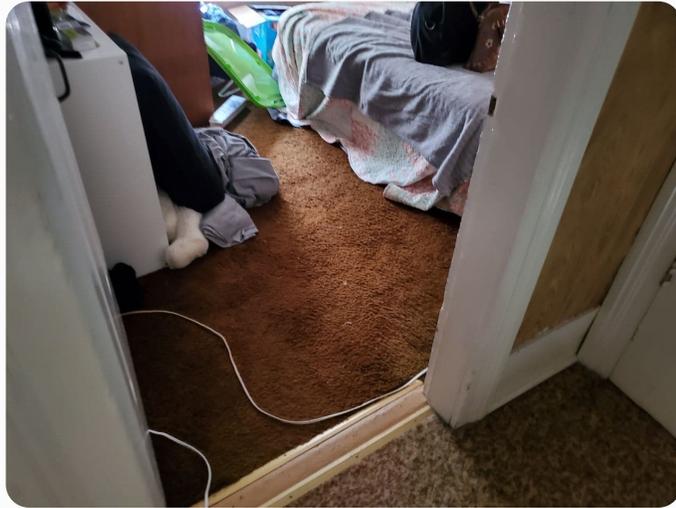
- At the time of the inspection, active moisture was detected along carpet found in the bedroom area.
- Evidence suggests that the source of the moisture found on the carpet may be from the window area.
- Moisture readings along the wall under the window area in the bedroom of concern did not yield any active moisture levels.
- Carpet is a highly retentive material that can trap particulates & allergens (pollen, spores, dust, etc.) and may increase reactions in individuals with predisposed sensitivities or medical conditions.
- It is recommended to remove the carpet in the affected bedroom area in order to better ascertain and address the moisture source; while removing the carpet as a potential source for contaminants.
- It is recommended to replace all carpets, especially if older than 10 years, with a non-porous alternative, such as laminate or hardwood.

Upper level bedroom area; active moisture detected along the carpet
