## VIRTUAL ASSESSMENT REPORT

Address of the Inspected Property: **341 Pennington Street Moores Mills, BC**

Date: May 16, 2022

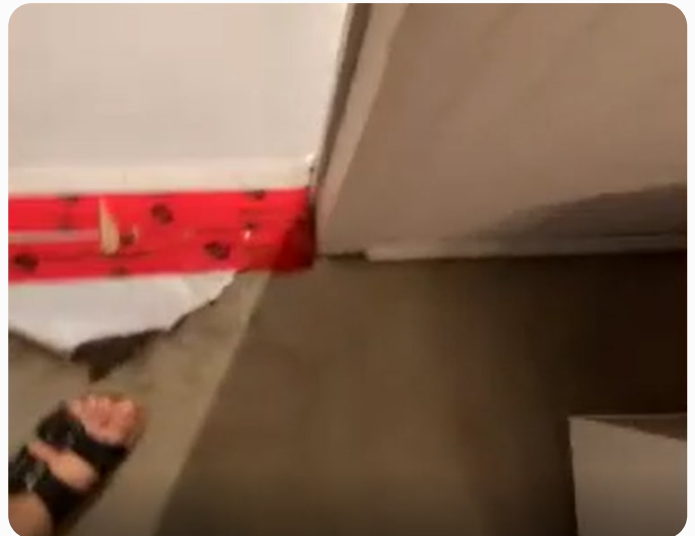
*Problematic area under the floor. Needs to be removed*

- Professional mold remediation is recommended to be performed in the basement area in accordance with Residential Mold Removal Guidelines. This includes the removal of any non-structural building material that is contaminated with mold, active moisture, or rot. All residual surface areas will be thoroughly disinfected using HEPA vacuums and anti-fungal treatments. This work should be performed by trained indoor environmental professionals and be verified upon completion to ensure clearance criteria have been met before any reconstruction begins;
- It is recommended to ensure that all areas in the basement are well ventilated at all times and that levels of relative humidity are maintained to be between 30-50% year-round.

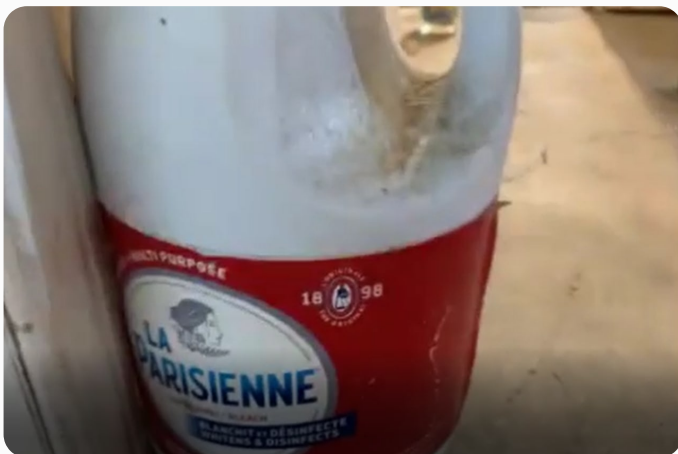
*Disinfectant was used*

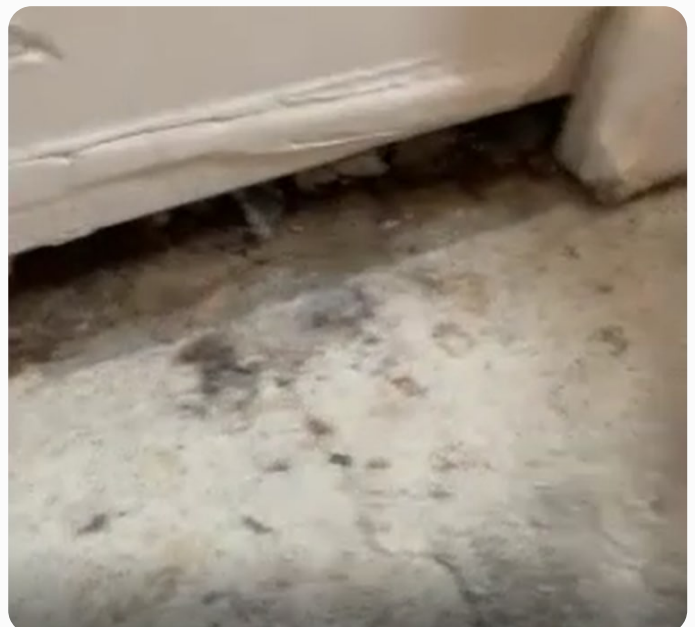
*Discoloration was observed along the  
perimeter around the baseboards*

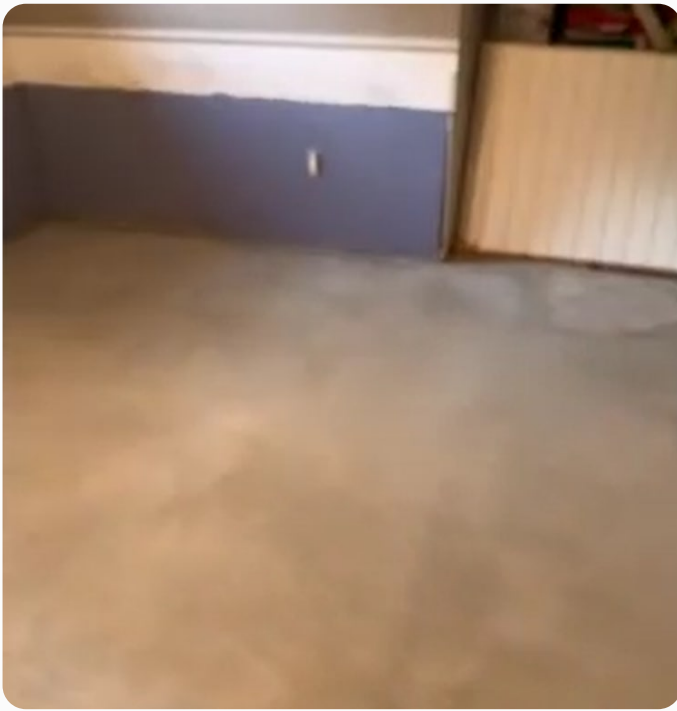
*Sump pump is located in the corner*

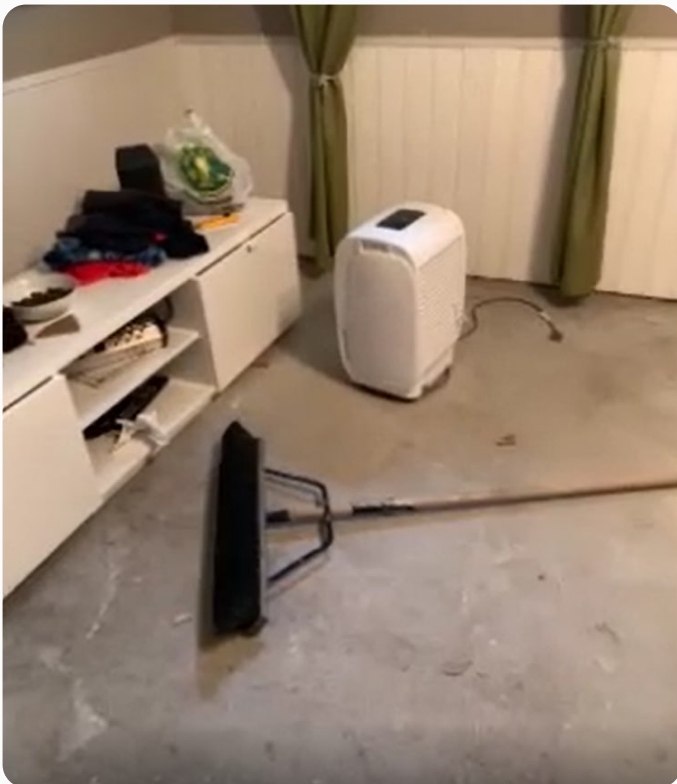
*Dehumidifier is not being used*

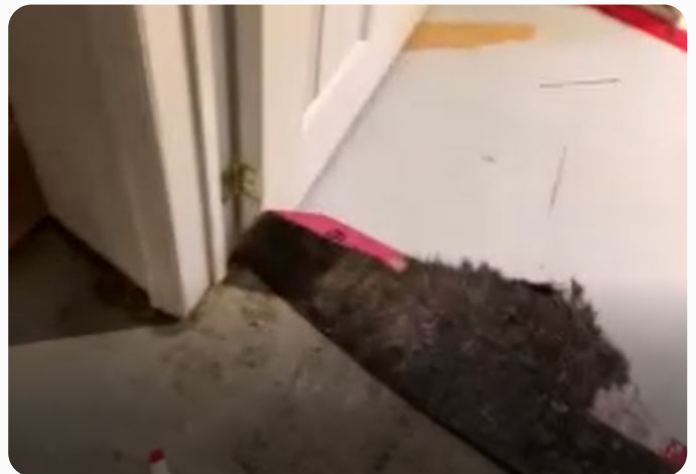
*Problematic area under the floor. Possible trapped moisture.*

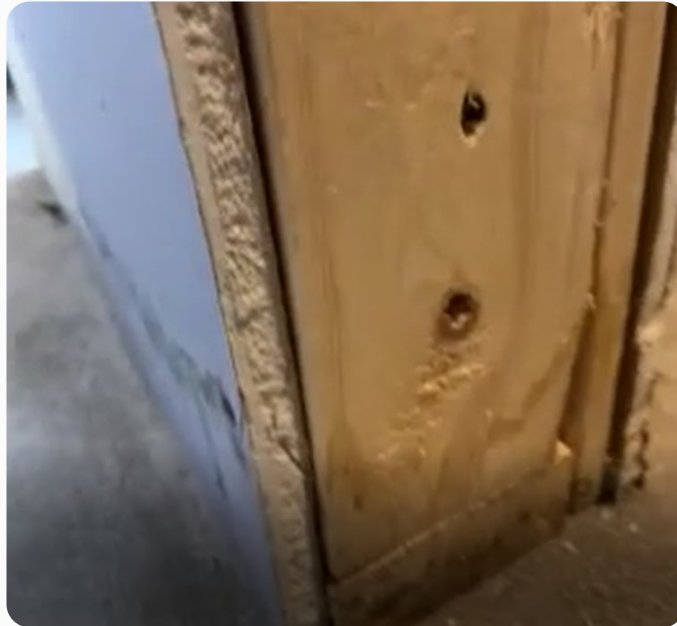
*Discoloration was noted on the drywall where the water level was present during the flood*
