VIRTUAL ASSESSMENT REPORT

Address of the Inspected Property: **341 Pennington Street Moores Mills, BC**

Mold Busters conducted a virtual inspection at 341 Pennington Street Moores Mills, BC, on May 16, 2022.

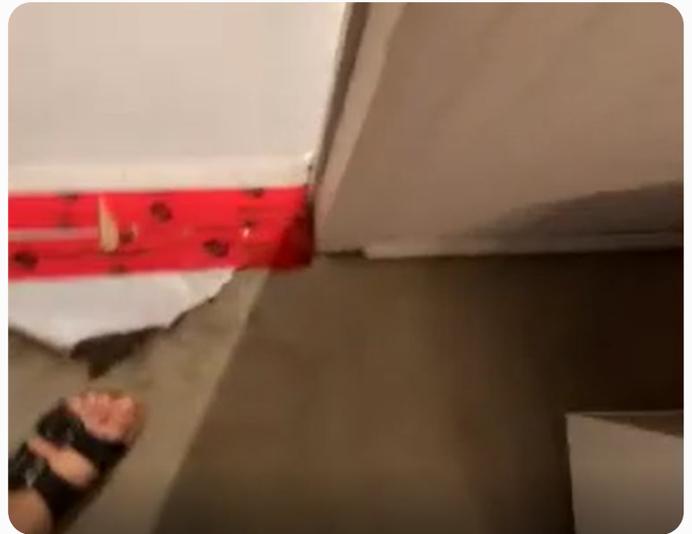
Problematic area under the floor. Needs to be removed

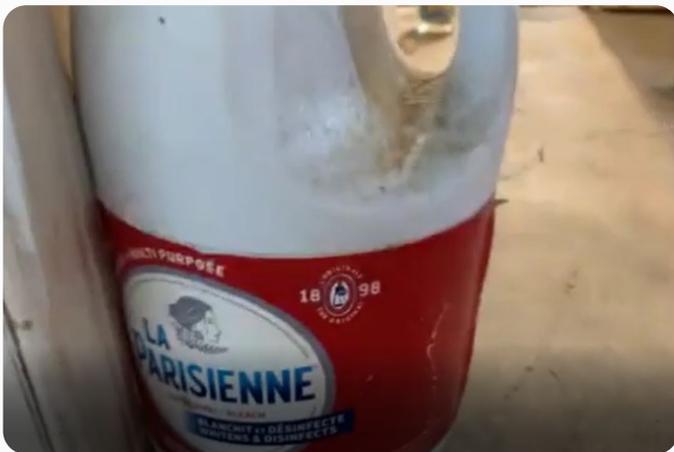
Disinfectant was used

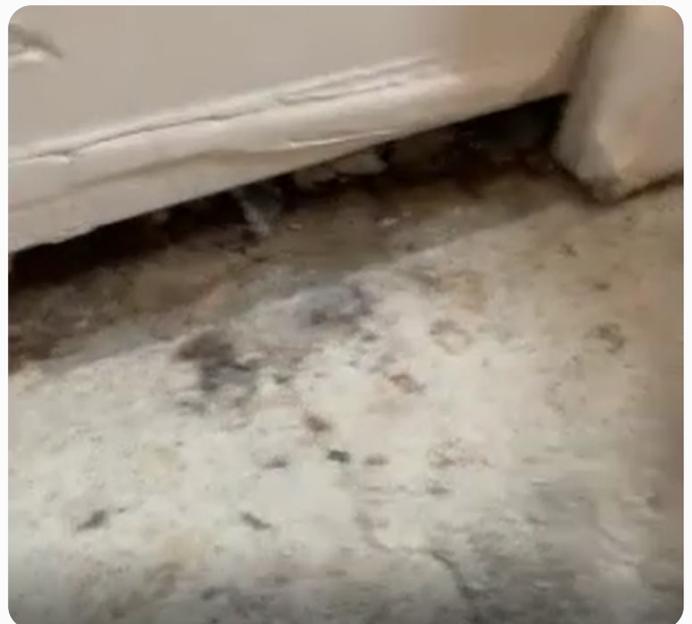
Discoloration was observed along the perimeter around the baseboards

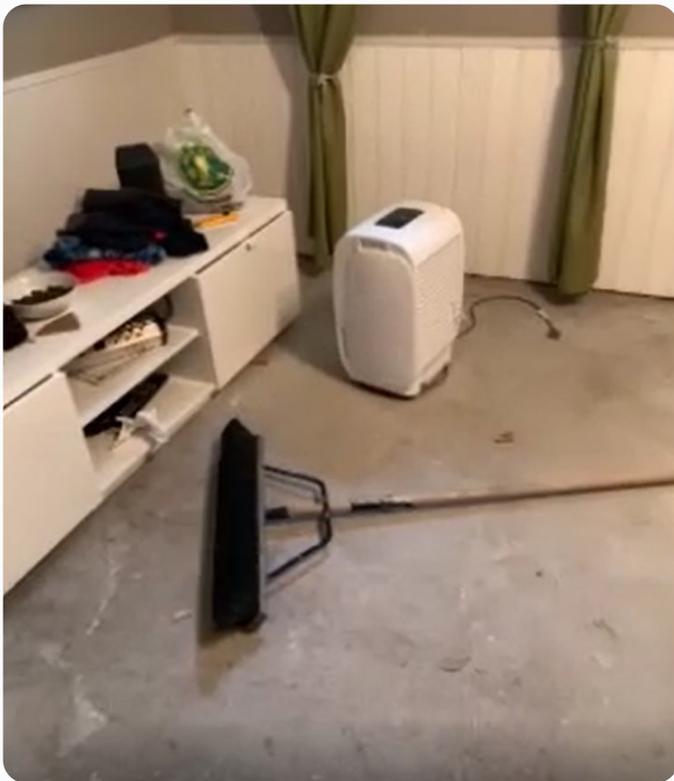
Dehumidifier is not being used

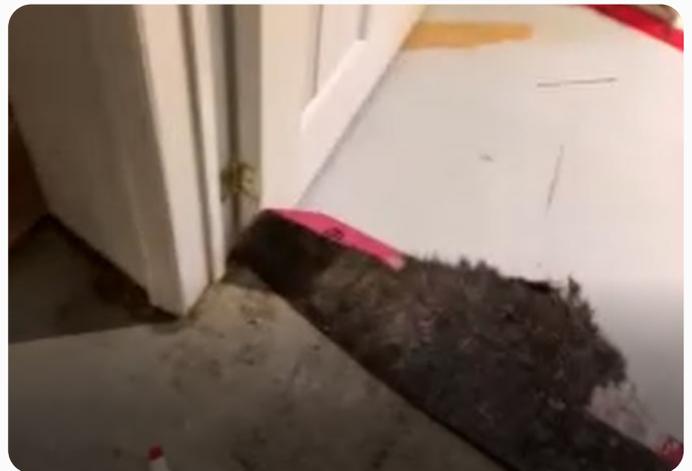
Problematic area under the floor. Possible trapped moisture.

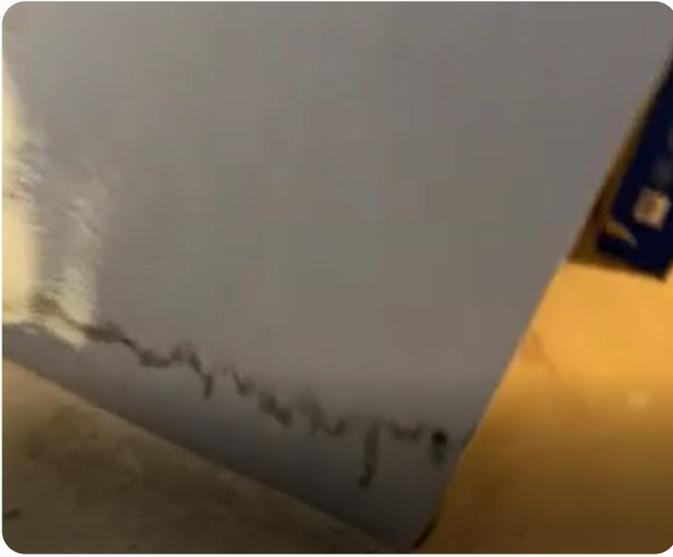
Water damage was noted on the wall

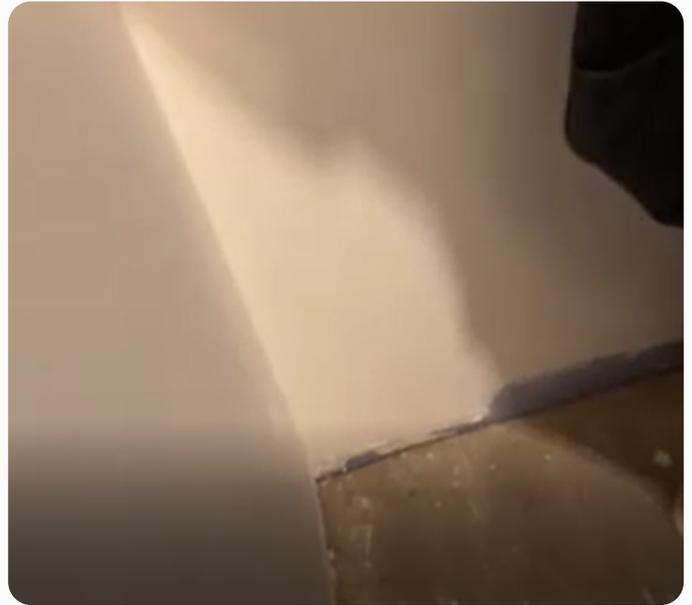
Discoloration was observed in the corners

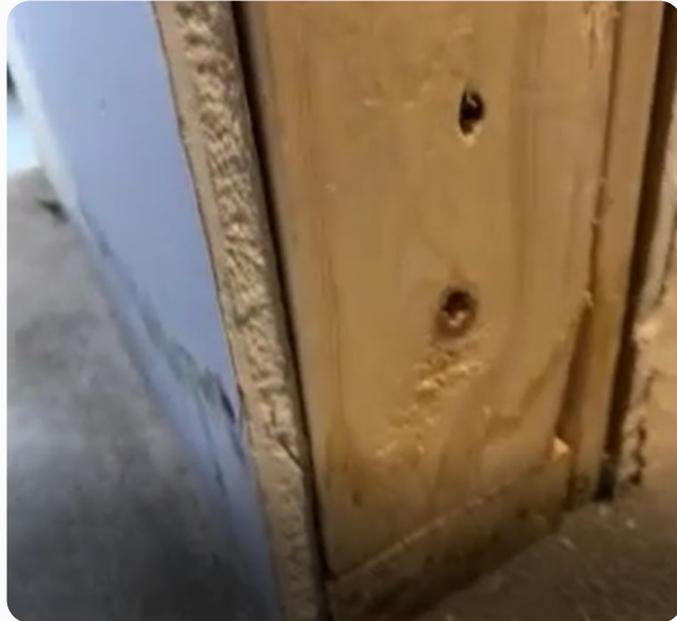
Discoloration was noted on the drywall where the water level was present during the flood
