# VIRTUAL ASSESSMENT REPORT

Address of the Inspected Property: **341 Pennington Street Moores Mills, BC**

Date: May 16, 2022

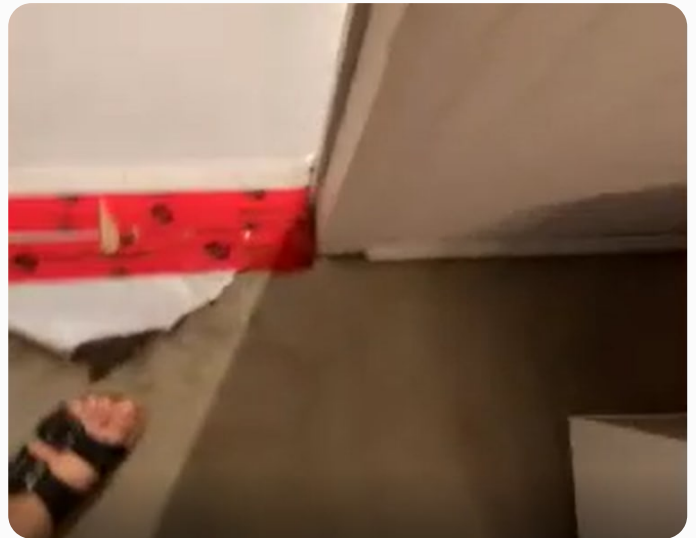
*Problematic area under the floor. Needs to be removed*

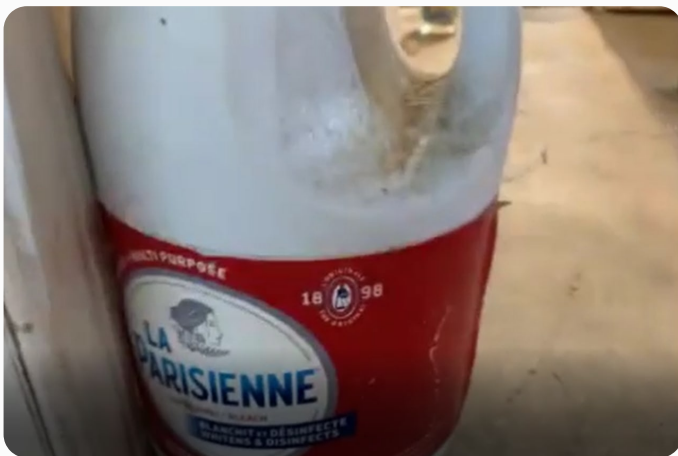
*Disinfectant was used*

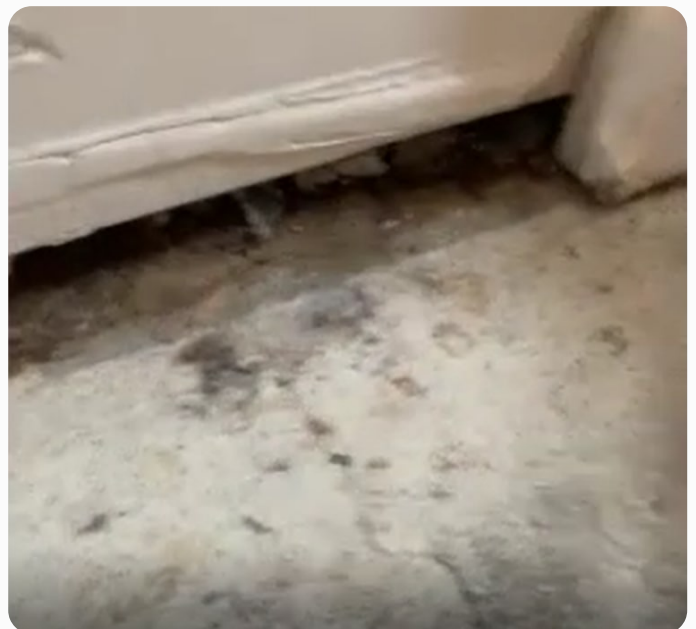
*Discoloration was observed along the perimeter around the baseboards*

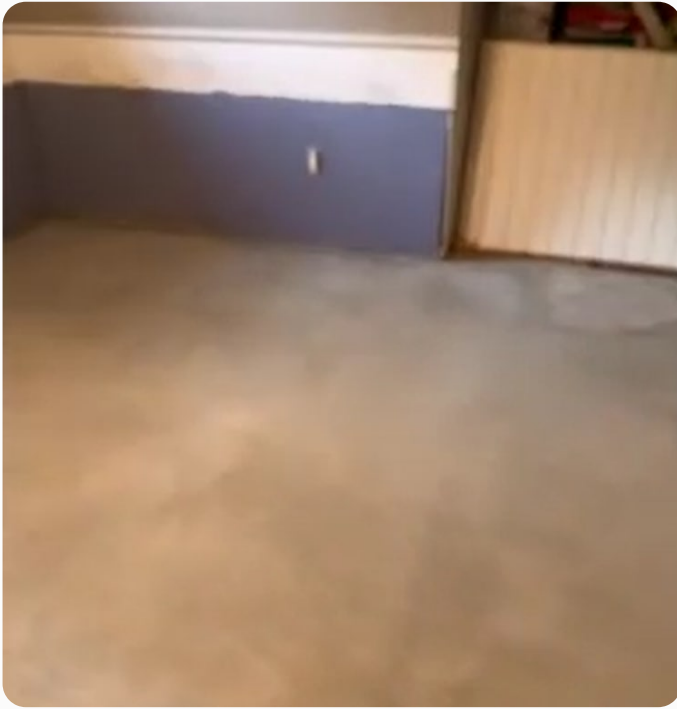
*Sump pump is located in the corner*

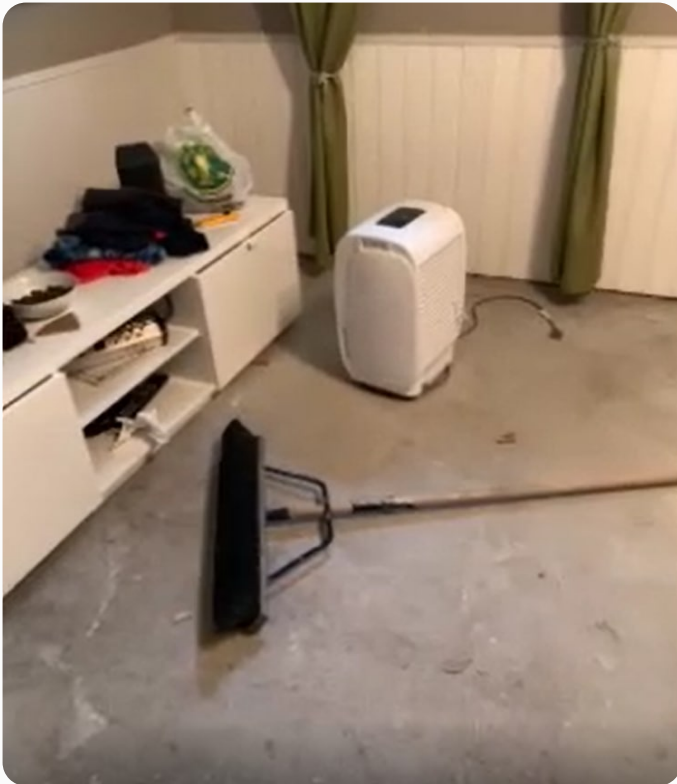
*Dehumidifier is not being used*

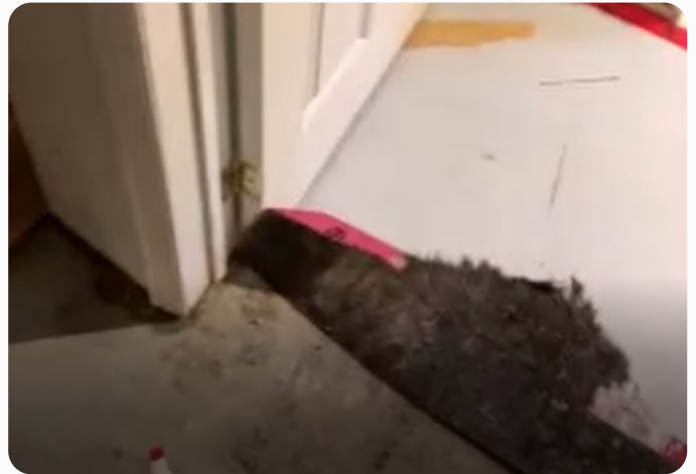
*Problematic area under the floor. Possible trapped moisture.*

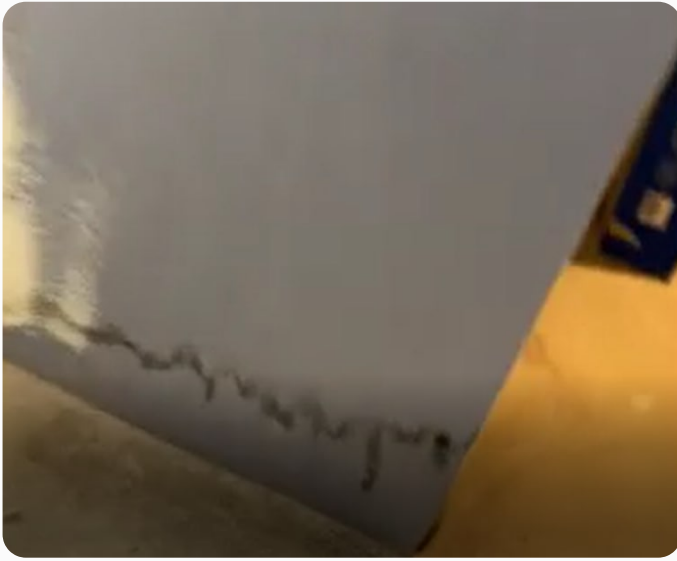
*Water damage was noted on the wall*

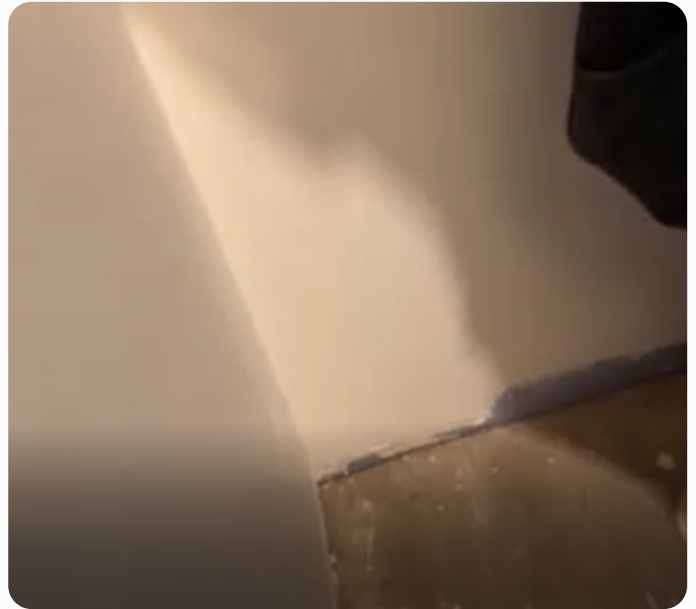
*Discoloration was observed in the corners*

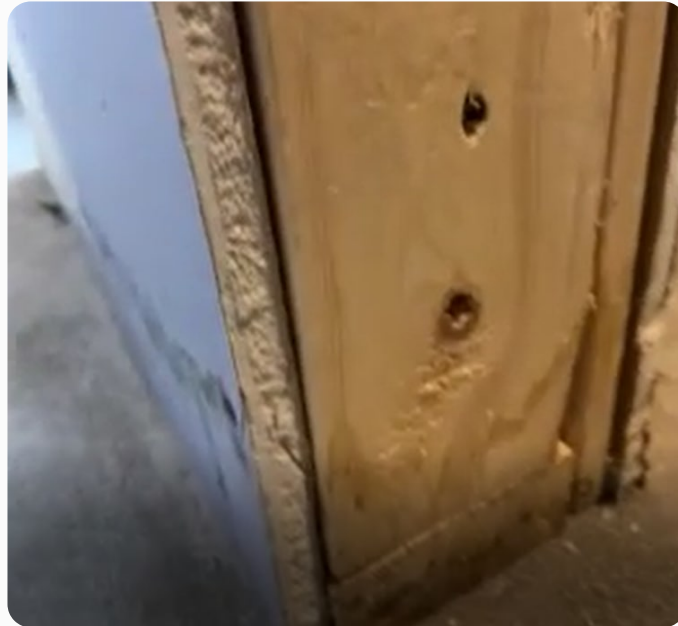
*Discoloration was noted on the drywall where the water level was present during the flood*
