VIRTUAL ASSESSMENT REPORT

Address of the Inspected Property: 341 Pennington Street Moores Mills, BC

Mold Busters conducted a virtual inspection at 341 Pennington Street Moores Mills, BC, on May 16, 2022.

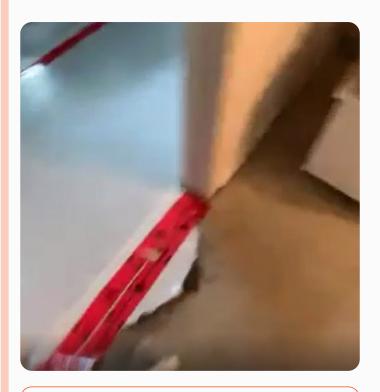
Problematic area under the floor. Needs to be removed

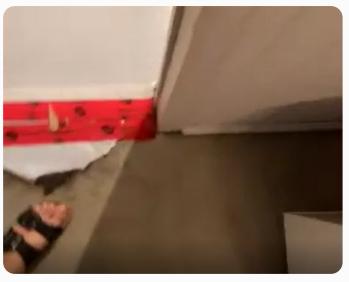
Problematic area under the floor. Needs to be removed

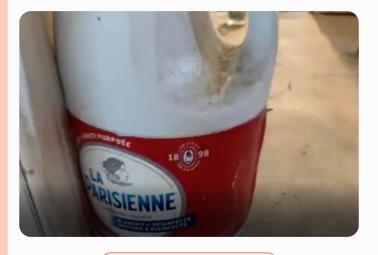
Disinfectant was used

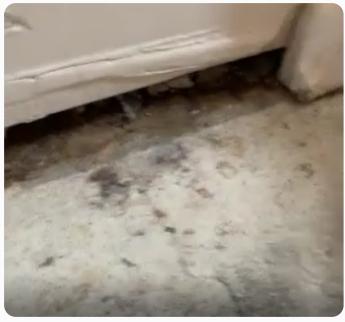
Discoloration was observed along the perimeter around the baseboards

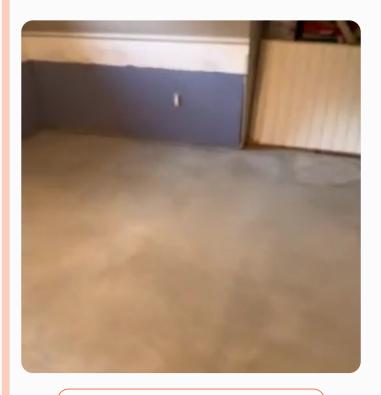
Sump pump is located in the corner

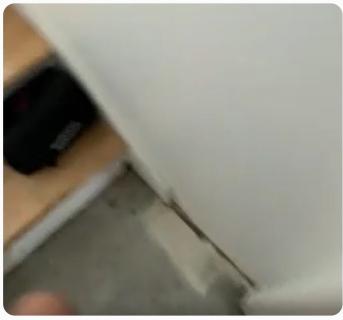
Discoloration and water damage were observed on and by the stairs

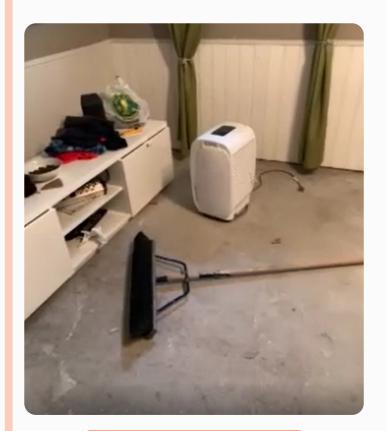
Dehumidifier is not being used

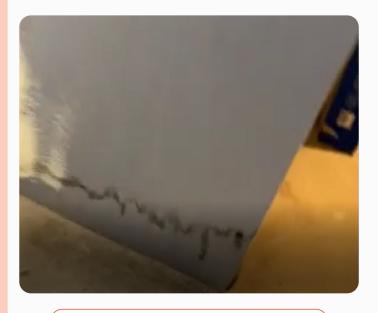
Water damage was noted on the wall

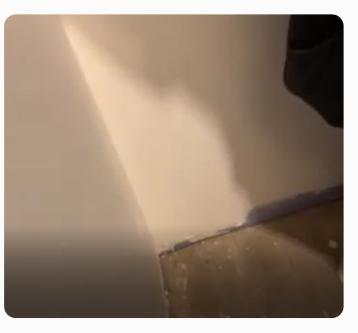
Discoloration was observed in the corners

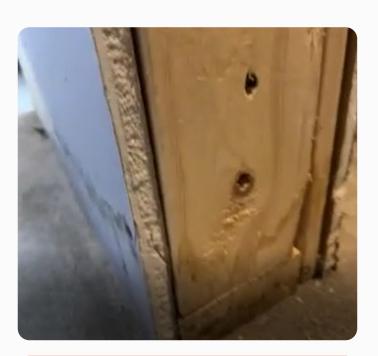
Discoloration was noted on the drywall where the water level was present during the flood
