# INDOOR ENVIRONMENTAL ASSESSMENT

Sorry, we have no imagery here.

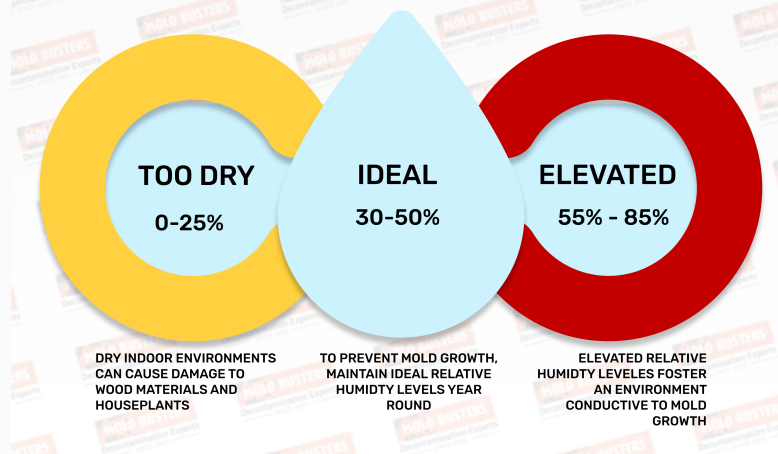
### 🔍 GENERAL OBSERVATIONS:

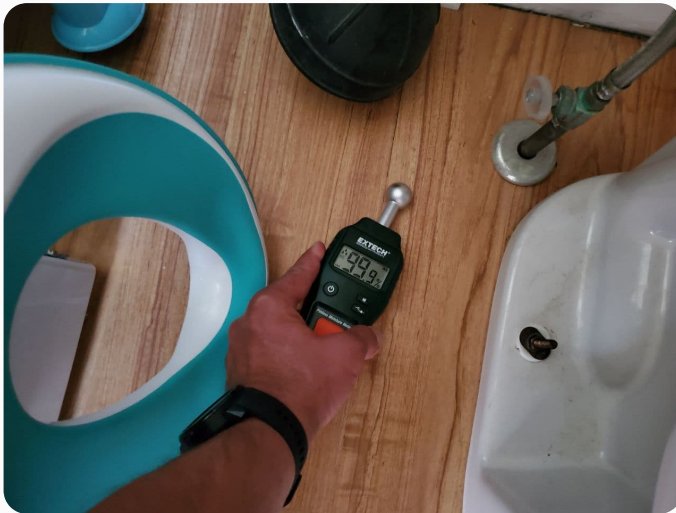
*Active moisture detected around the toilet;  
main level*

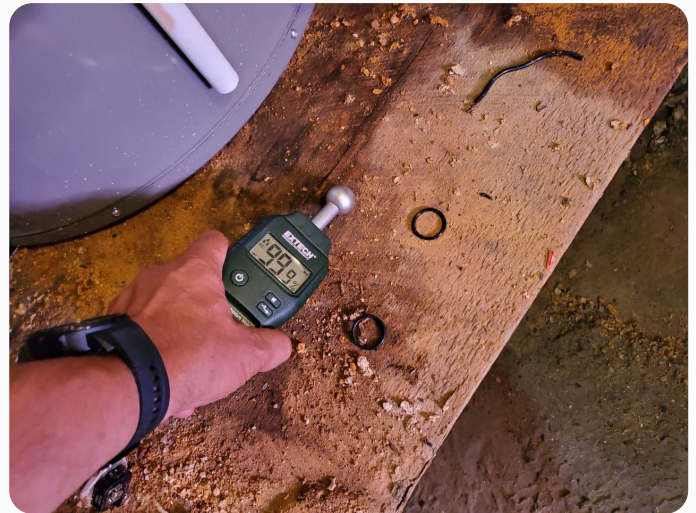
*Wooden components affected by moisture  
around the water tank*

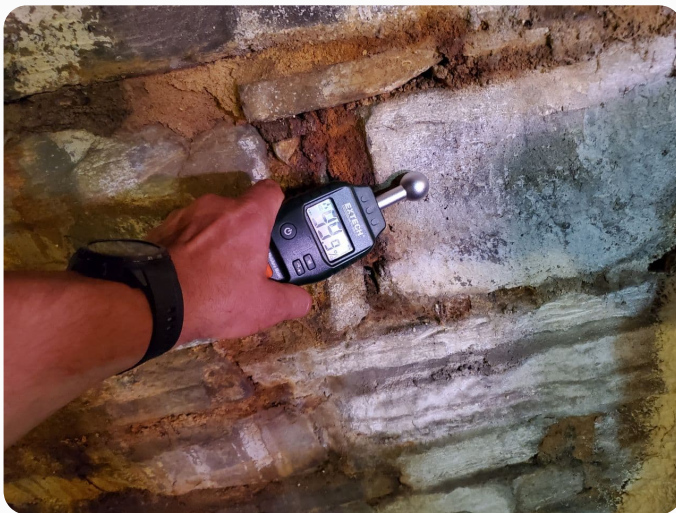
*Active moisture content detected along the  
foundation walls in the Basement Area*

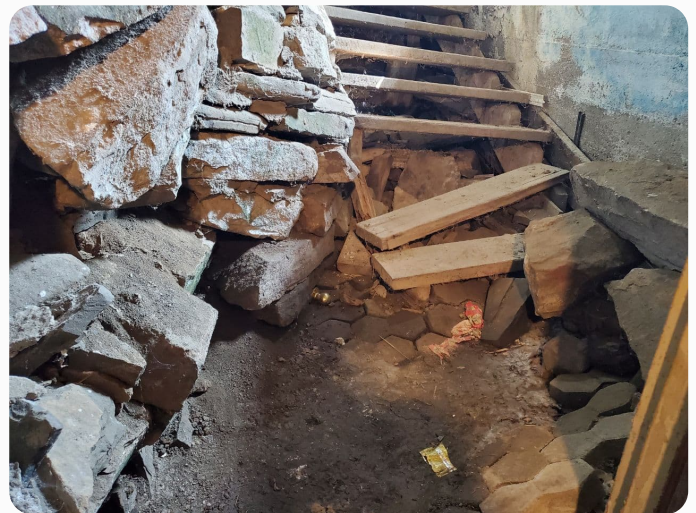
*Compromise to the stairs noted; entrance to  
the basement area*

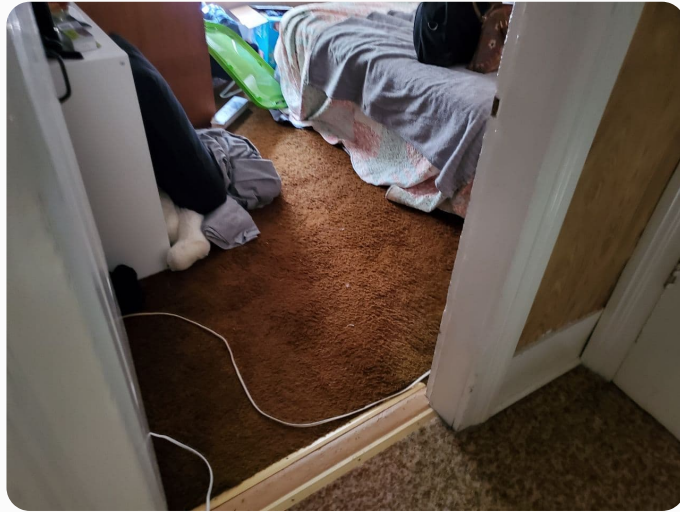
*Upper level bedroom area; active moisture detected along the carpet*
