INDOOR ENVIRONMENTAL ASSESSMENT

- **&** Report Prepared for: **Amelia Tremblay**
- Address of the Inspected Property: 341 Pennington Street, Moores Mills, BC

Date: August 18, 2022

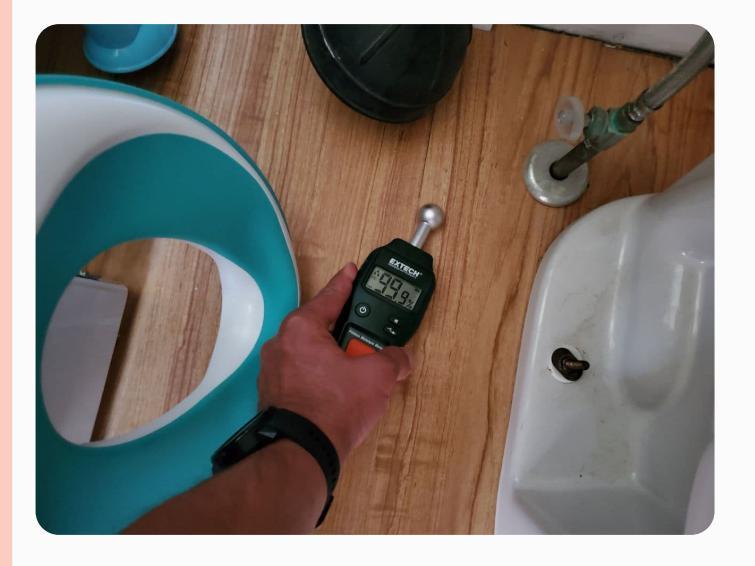
• At the time of the inspection, active moisture was detected along the flooring in the bathroom, near the toilet. This may be the result of a leaky seal, or compromised wax gasket.

Active moisture detected around the toilet; main level

• It is recommended to contact a plumber to assess and address any potential leak sources.

• Once the leak has been addressed, it is recommended to remove and/or treat the affected subflooring materials in the bathroom area.

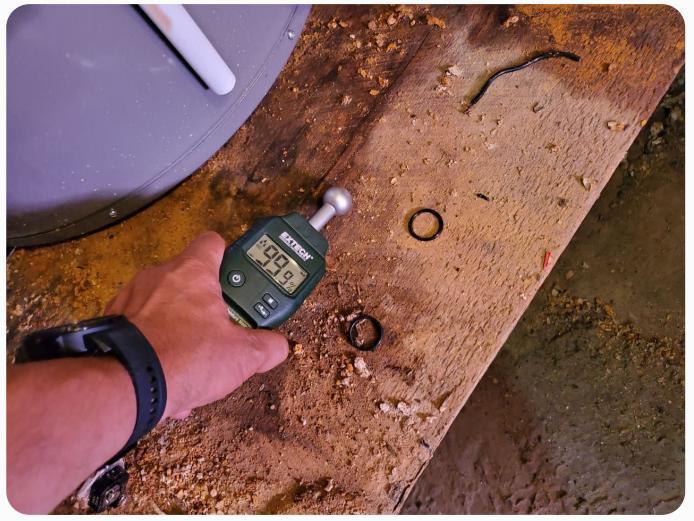
• Wood materials (plywood platform, framing, etc.) were found to be compromised by moisture, near the water tank area.

• A water valve near water tank area was found to be dripping at the time of the inspection, contributing to the moisture content along the floor.

Wooden components affected by moisture around the water tank

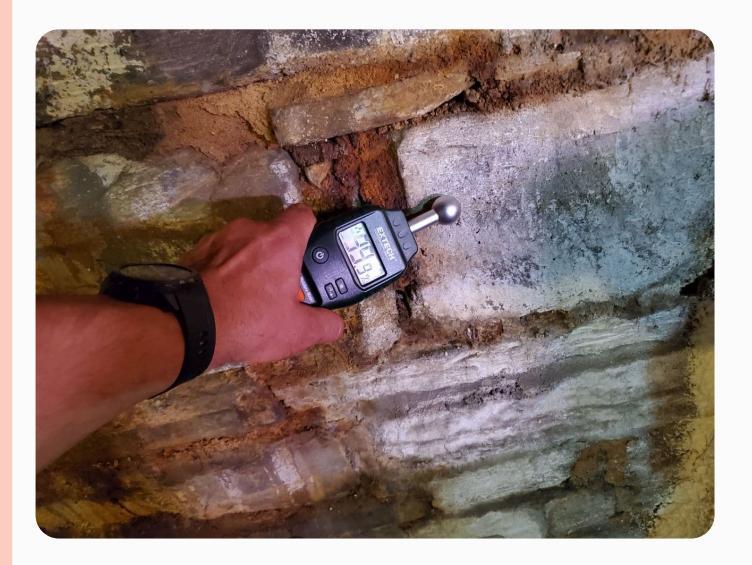
• The foundation walls were found to display evidence of moisture intrusions, by means of water staining and efflorescence. The age of the home and the materials used for the foundation wall materials may required a professional foundation specialist to assess the current state of the foundation wall materials. • A moisture source contributing to the visible moisture issues in the basement along the foundation walls and flooring is related to inadequate moisture diversion strategies implemented along the exterior of the home.

Active moisture content detected along the foundation walls in the Basement Area

• It is recommended to have the foundation assessed and/or addressed by a professional in that field.

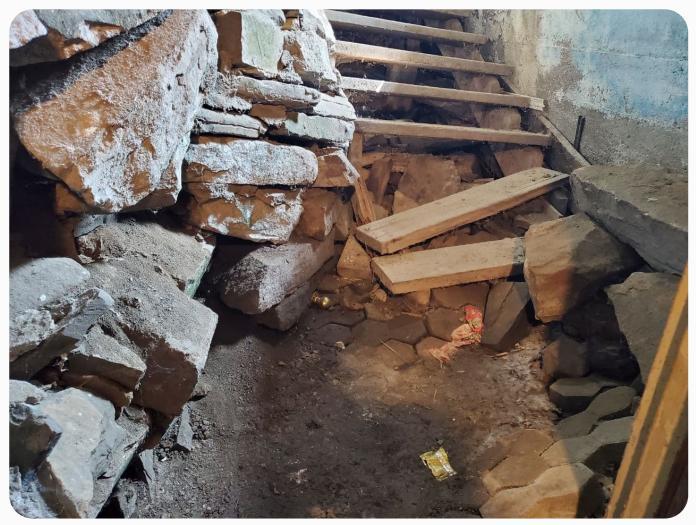
Compromise to the stairs noted; entrance to the basement area

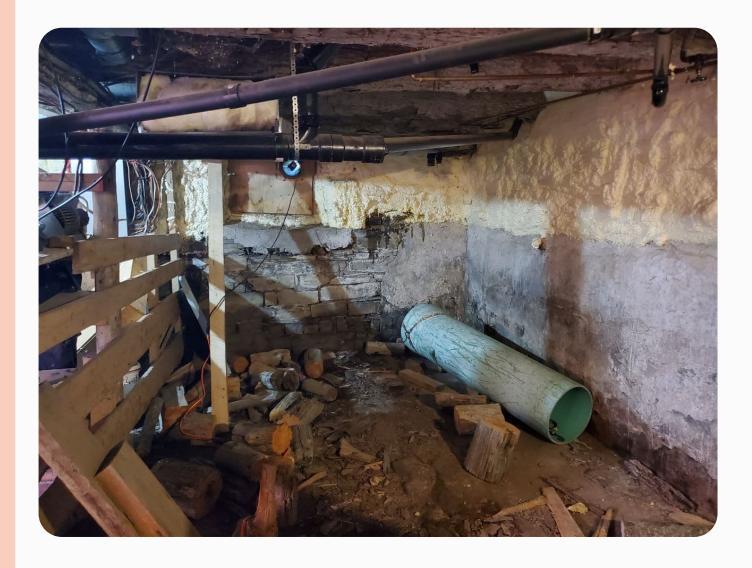
• Visible mold growth was observed on the walls and floors around the water tank and along the exterior walls in the Basement Area.

• It was observed that firewood and logs are being kept and possibly cut in the basement area. It is generally recommended to do so outside of the property so as to prevent the introduction of mold spores, termites or other sources of building contaminants that may be present in firewood, logs or other related materials.

Accumulation of firewood & debris noted throughout the basement area; visible mold noted on the walls

• It is recommended to avoid bringing in and chopping firewood in the interior of the home.

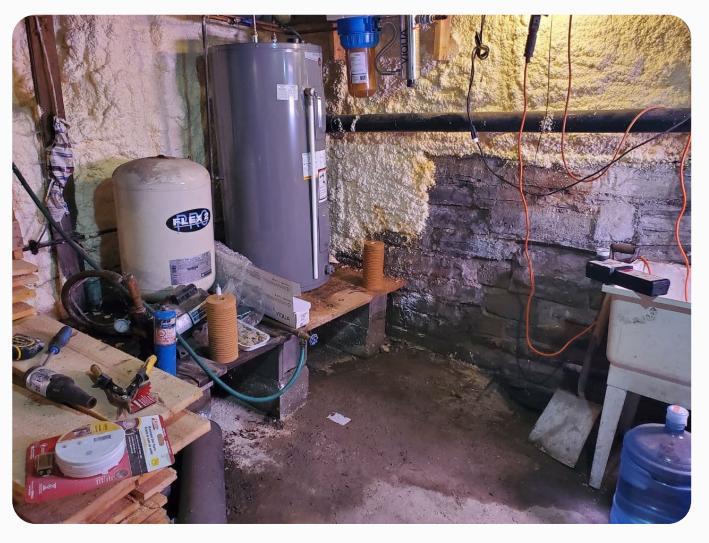
It was observed that the basement area is partially insulated with polyeurethane sprayfoam along the upper portions of the exterior walls. The lower portions are not insulated. This may create a thermal imbalance during the colder months, which can facilitate condensation and thus, conditions conducive to fungal growth.

General photo of the water tank; partial insulation of exterior walls

• It is recommended to insulate the remaining portion of the exterior walls in the basement area in order to achieve a more balanced thermal resistance.

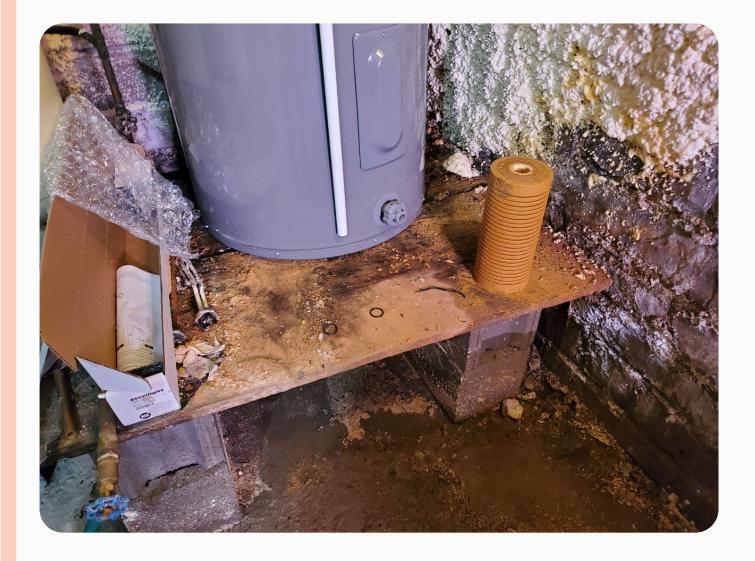
Visible discoloration noted along the wood material

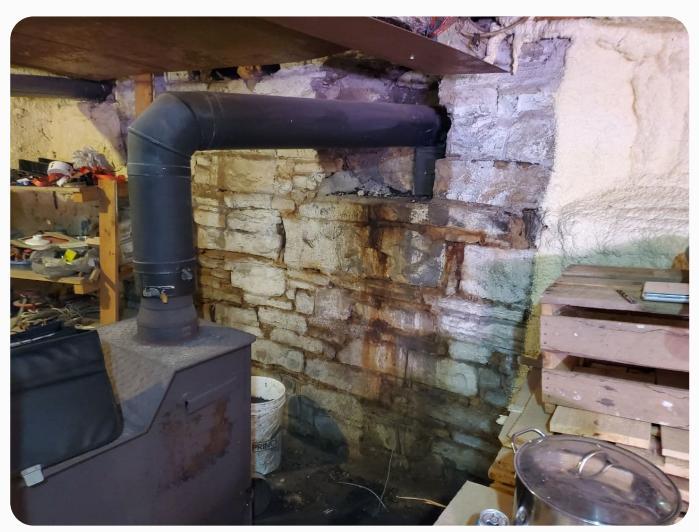
Visible mold growth observed on the foundation walls

• Professional mold remediation is recommended to be performed in the affected areas (basement area, main level bathroom and upper-level area) in accordance with <u>Residential Mold Removal Guidelines</u>.

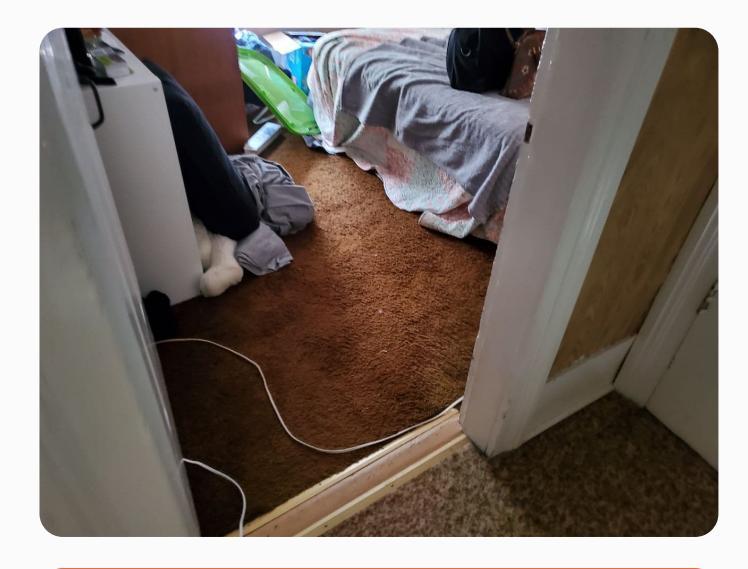
• At the time of the inspection, active moisture was detected along carpet found in the bedroom area.

• Evidence suggests that the source of the moisture found on the carpet may be from the window area.

Upper level bedroom area; active moisture detected along the carpet

It is recommended to remove the carpet in the affected bedroom area in order to better ascertain and address the moisture source; while removing the carpet as a potential source for contaminants.
