PROJECT CLEARANCE REPORT

Address of the Inspected Property: **341 Pennington Street, Moores Mills, BC**

Pre-Remediation Assessment*August 5, 2022*

Post-Remediation Verification

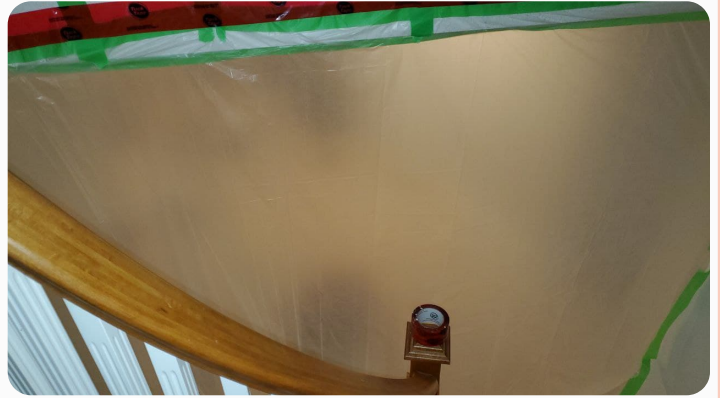
Remediation Project: August 12, 2022;
Containment setup

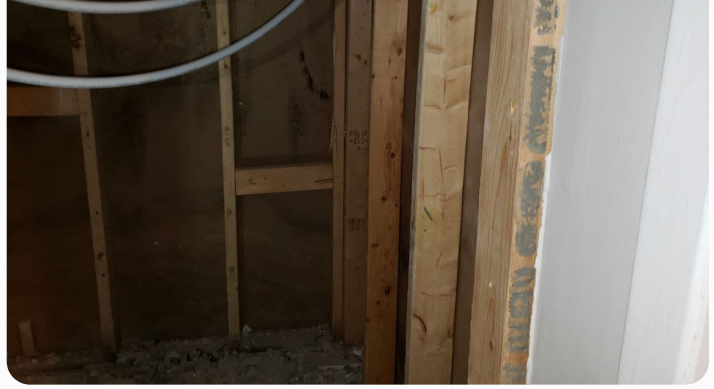
*Post-Remediation Verification: August 19, 2022;
Shower area found to be in the renovation
process at the time of the assessment*

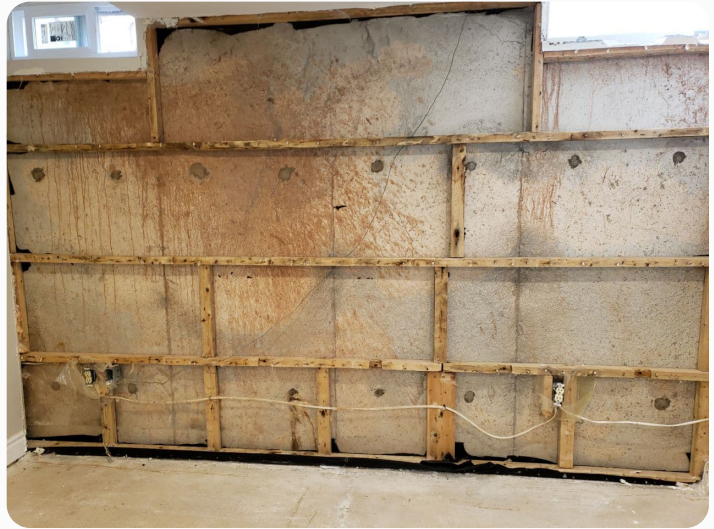
- At the time of the assessment the shower area was found to be in the renovation process, and visual mold was found behind the wall, however, the client mutually agreed not to continue with work as per personal reasons;

*Post-Remediation Verification: August 19,
2022;; Visual mold observed on the wall behind
removed shower*

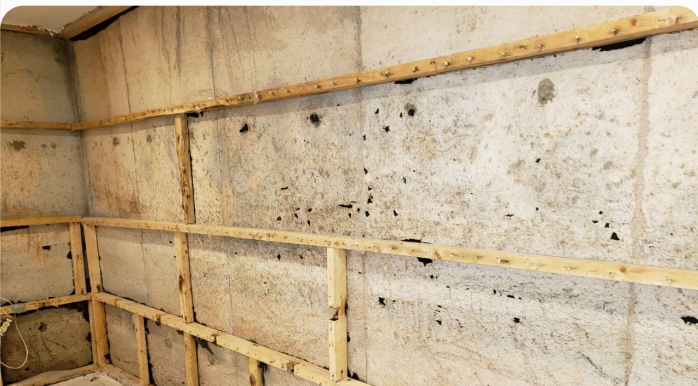
- Visual assessment of the treated area revealed cracks on several areas of the foundation walls;
- A discolored portion of the framing components was observed; An instant swab test was performed to determine the nature of the discoloration, and the results yielded a negative analysis for biological contaminant (i.e., fungi); The observed discoloration is non-fungal in nature;

Post-Remediation Verification: August 19, 2022;
An evidence of crack in the foundation wall

2. It is recommended to contact a foundation specialist to check the integrity of the foundation walls and fix any issue;
