PROJECT CLEARANCE REPORT

Address of the Inspected Property: **341 Pennington Street, Moores Mills, BC**

Date: August 12, 2022

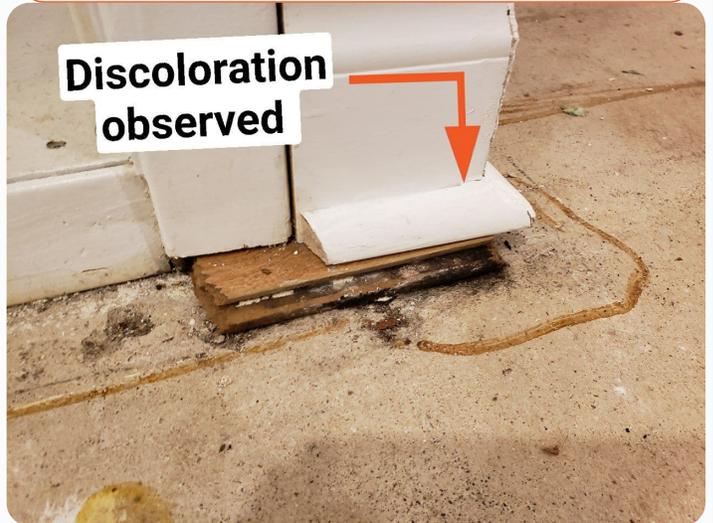
During the remediation process, it was revealed that other areas of the basement were contaminated as well. Evidence of mice tunneling through the insulation explained the thermal anomalies observed. This degradation could impact the integrity of the insulants, exacerbating condensation issues behind the wall cavity which lead to a scope increase. The Project Supervisor suggested that all drywall, vapor barrier, and other affected organic-based materials be around the perimeter of the basement area. The client approved the scope increase and all suggestions were added to the existing plan of action.

Pre-Remediation Assessment: August 5, 2022;
thermal anomalies detected

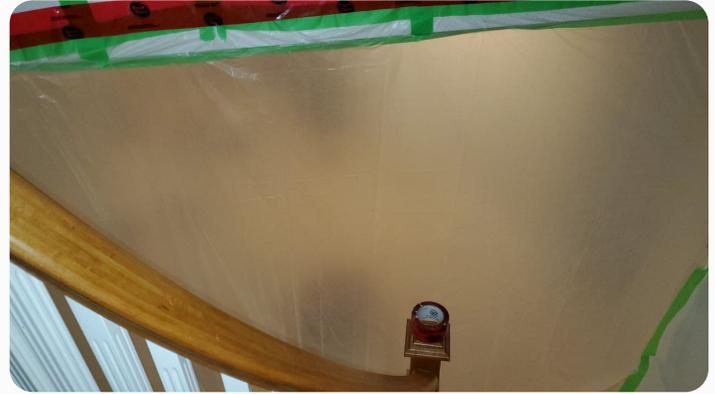
Remediation Project: August 12, 2022;
Containment setup

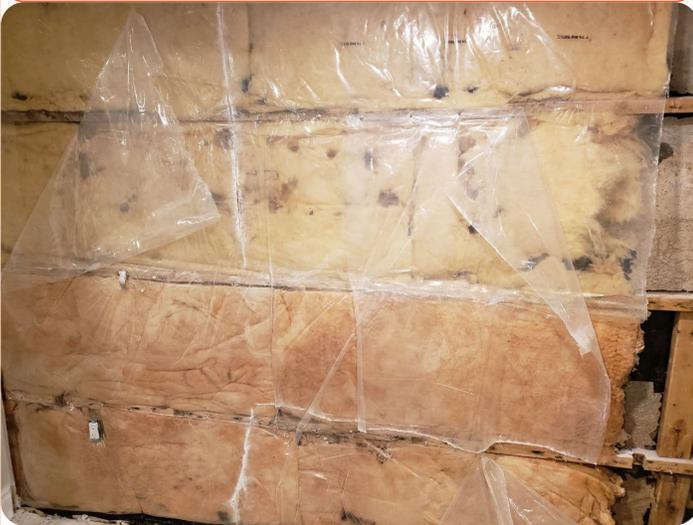
Remediation Project: August 12, 2022; An
evidence of mice droppings was found

1. It is recommended to contact a pest control specialist to assess, correct and implement preventative measures against further rodent activity;

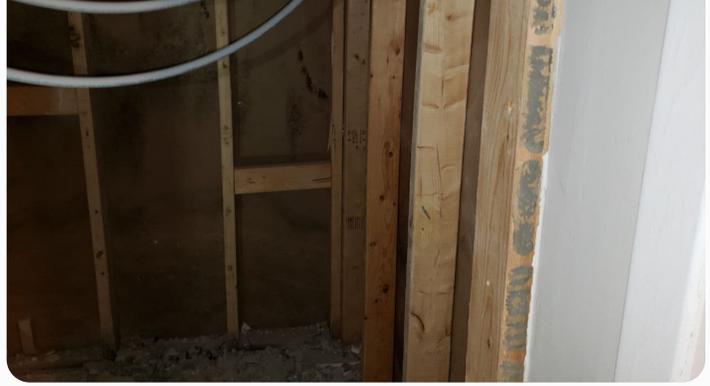
- At the time of the assessment the shower area was found to be in the renovation process, and visual mold was found behind the wall, however, the client mutually agreed not to continue with work as per personal reasons;

Post-Remediation Verification: August 19, 2022;
